Bare Board Material Performance after Pb-free Reflow

IPC/APEX March 31-Apr 2, 2009

Overview of Project

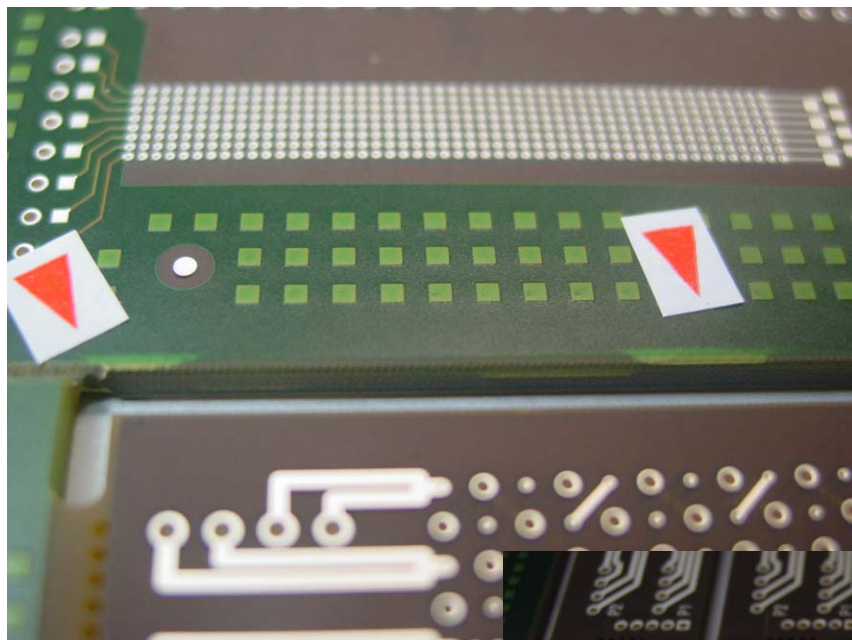
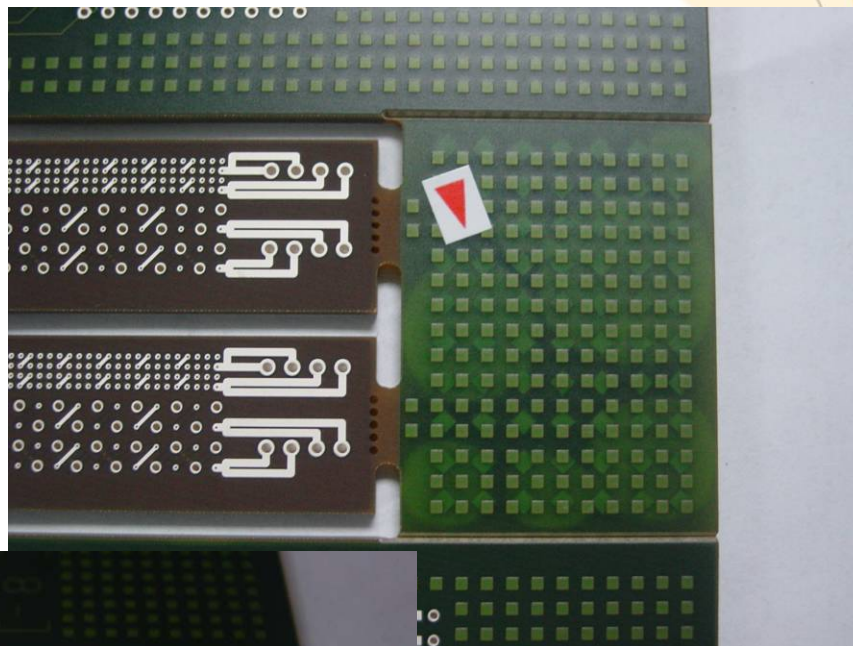
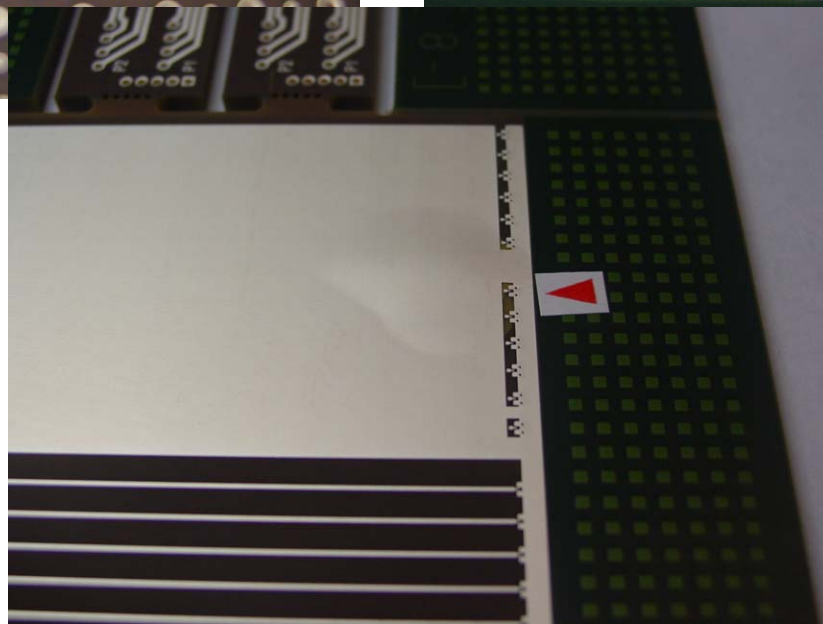
Some Materials showed Visible Defects after Reflow

<i>20 Layer Constructions</i>			
Dash Number	Material	Stackup (A=Low Resin Content, B=High Resin Content)	Results
A	Baseline Non-Filled Phenolic FR4	A	Blistering/delamination after 4X reflow. Minor discoloration
B	Baseline Filled Phenolic FR4	A	No defects
C	Filled Proprietary Resin FR4	A	No defects
D	Filled Phenolic FR4	A	No defects other than incoming
E	Unfilled Phenolic FR4	A	Minor blistering/delamination after 5X reflow
F	Unfilled Phenolic FR4	A	Minor blistering/delamination after 5X reflow
G	Filled Phenolic FR4	A	No defects
H	Unfilled Phenolic FR4	A	Major delamination and blistering after only 2X reflow
I	Filled Phenolic FR4	A	No defects
J	Filled Phenolic FR4	A	Minor blistering/delamination after 3X reflow
K	Unfilled Phenolic FR4	A	No defects
L	Hi-Speed Material	A	No defects
M	Hi-Speed Material	A	No defects
N	Hi-Speed Material	A	No defects other than incoming
P	Unfilled Phenolic FR4	B	Minor blistering/delamination after 6X reflow

Q	Filled Phenolic FR4	B	No defects
R	Unfilled Phenolic FR4	B	Major delamination and blistering after 6X reflow
S	Filled Phenolic FR4	B	No defects other than incoming

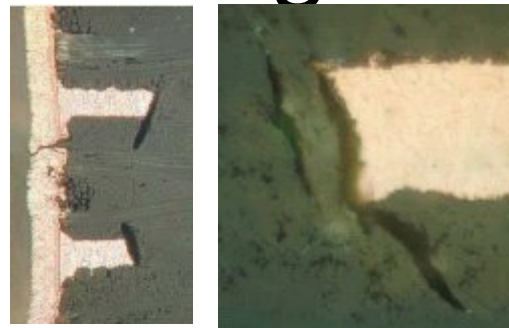
Eyebrow Cracking

Visual Inspection DOES NOT find these
Via Pitch makes a Big difference
Thickness Makes a Big difference
Resin Content – more to follow

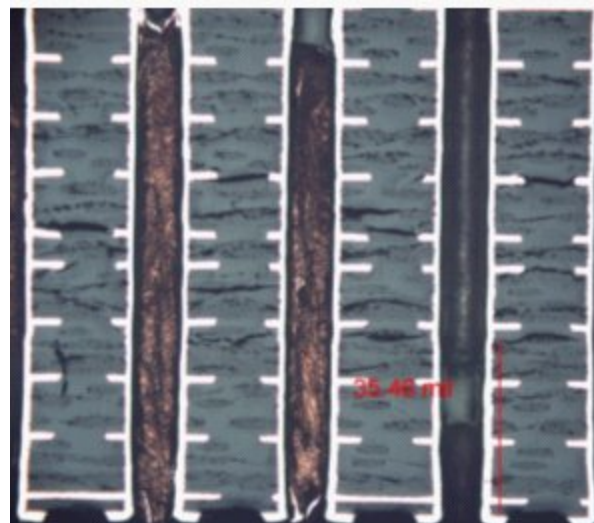
Longitudinal Cracks

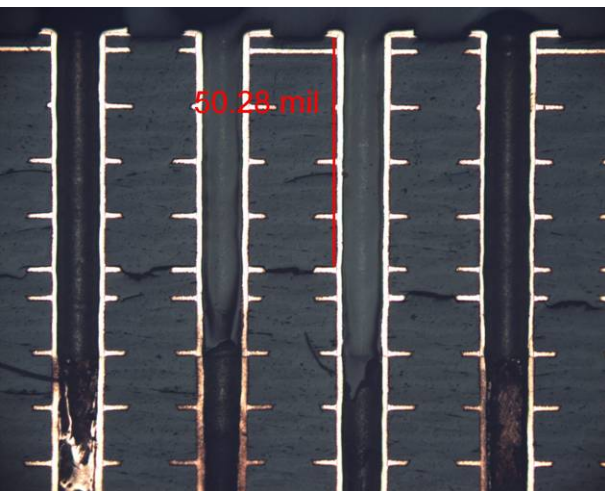
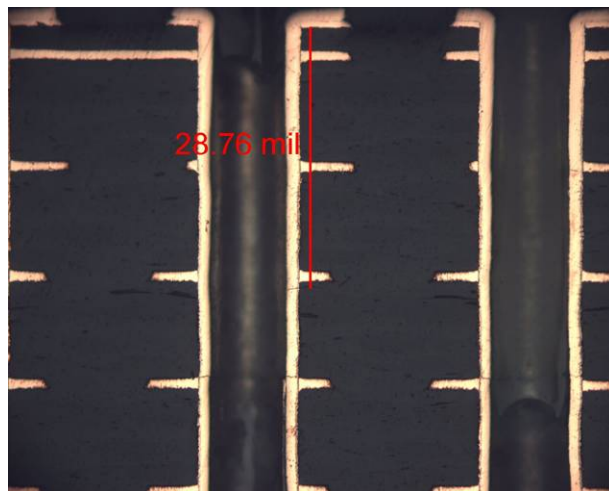
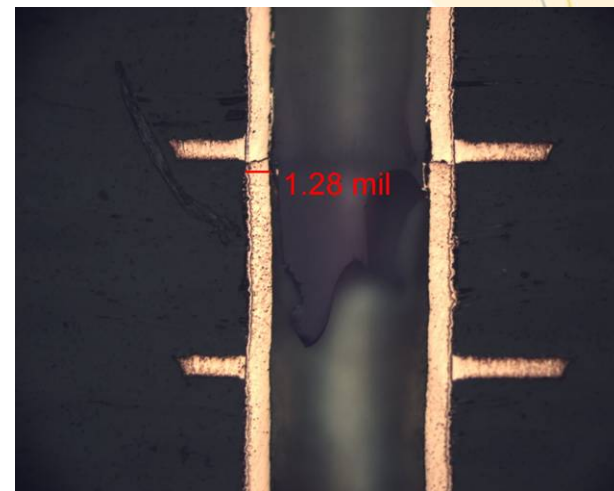
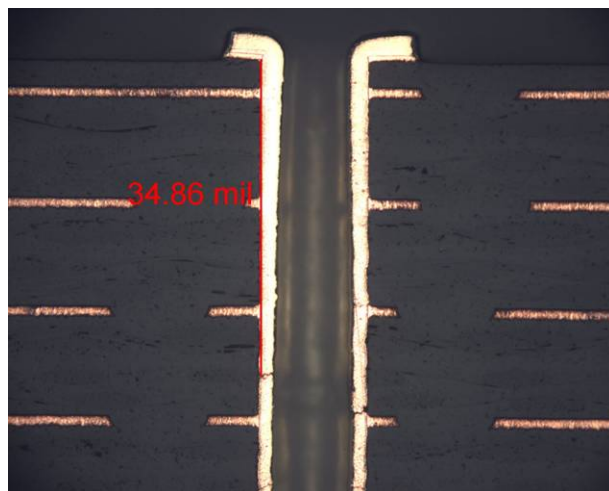
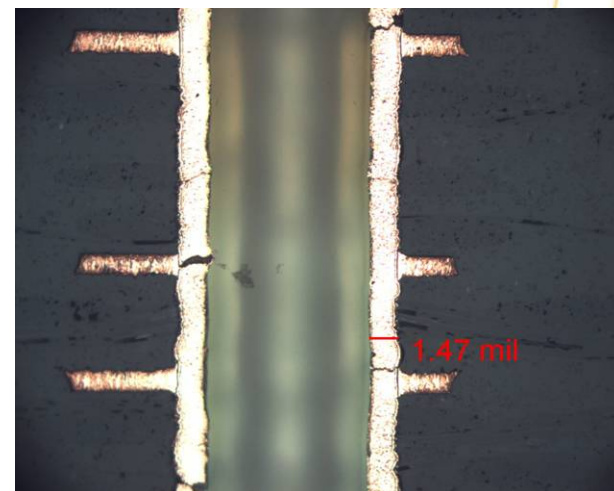
FA – ATC Example (G)

- For the 100 mil pitch samples, only material L has delamination after ATC.
- For the 0.8mm pitch samples, only material N did not delaminate after ATC.

- All failures are barrel cracks. There was no evidence of any interconnect separation or foil cracking in any of the samples.
- At 0.8mm pitch, for all materials except material N, there are multiple copper cracks and delamination.

0.8mm pitch (above)
.100" pitch (right)

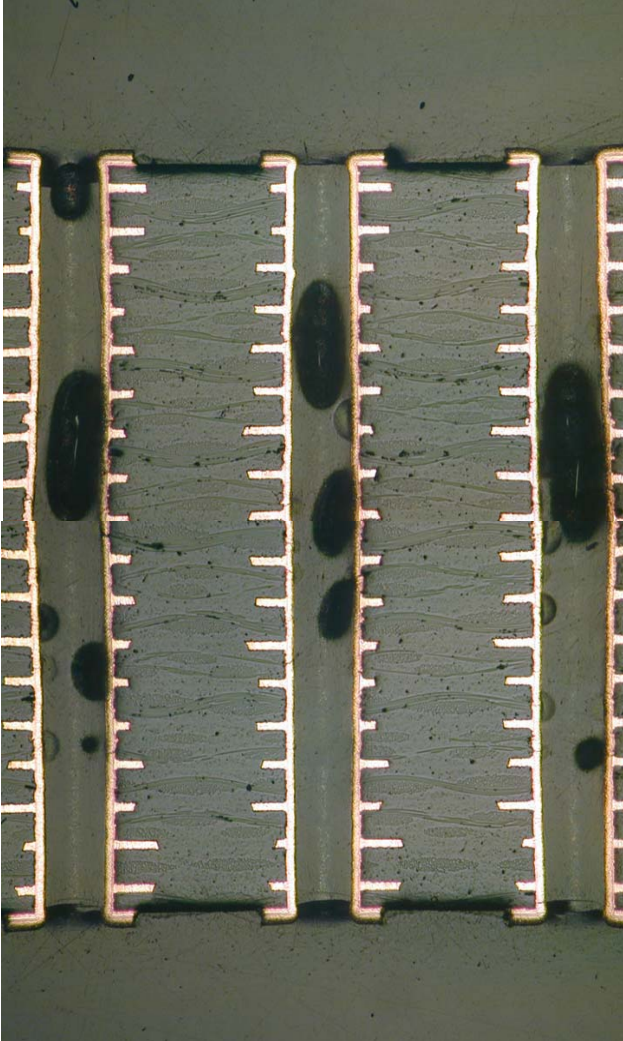
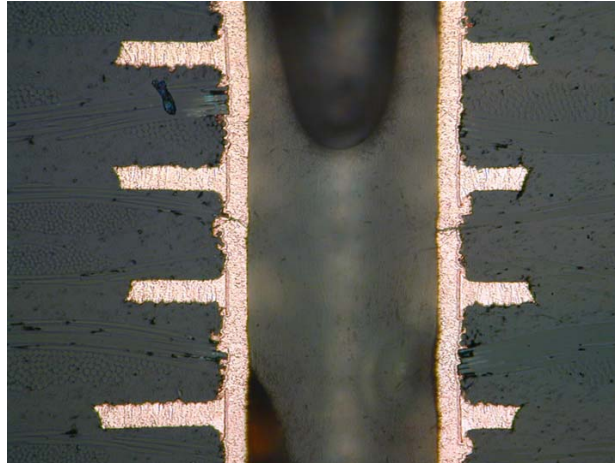
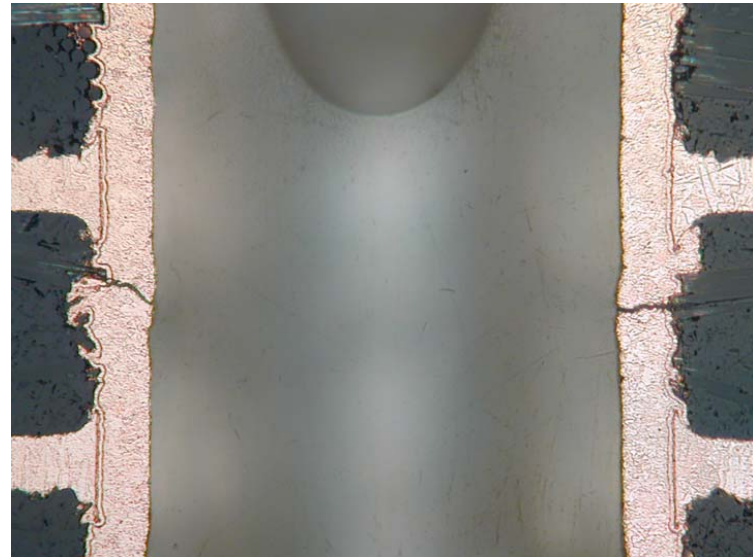
FA – IST As Built Example (G)

- At 1mm pitch (IST), 11 of the 20 layer constructions delaminated, including all high resin content constructions. An additional 4 of the 20 layer standard resin content constructions had eyebrow cracking. Three materials at 20 layer standard resin content and the 2 thick 6 layer constructions survived at 1mm pitch with no evidence of any material degradation.

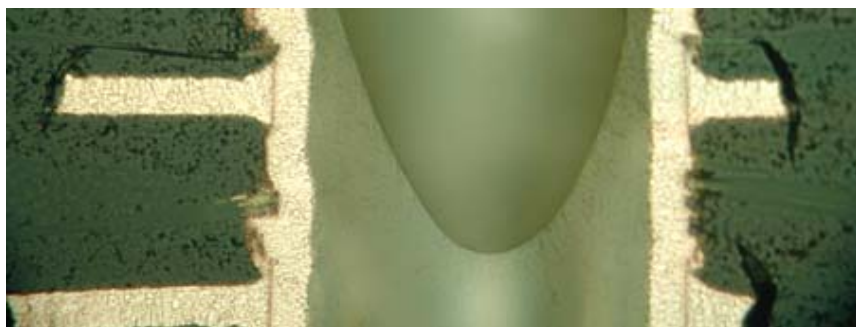
- Some materials delaminated at 1.00 mm pitch also
 - Eyebrow cracking also found

Example of Eyebrow
Cracking
(D)

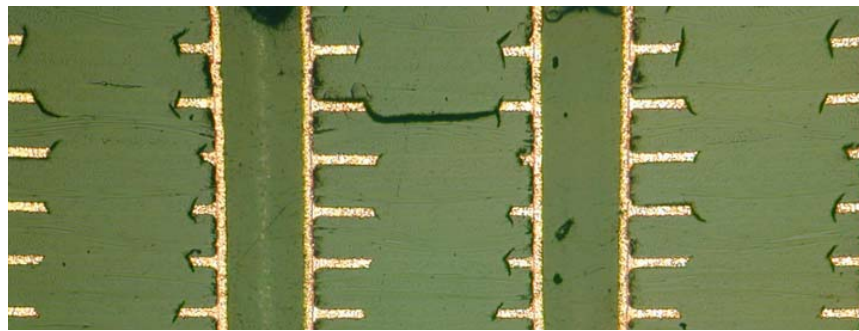
Example of Delamination
(I)
