Whisker Growth on SAC Solder Joints: Microstructure Analysis

Polina Snugovsky, Zohreh Bagheri, Marianne Romansky
SMTA Toronto, May 15th, 2008

History of the Examined Samples

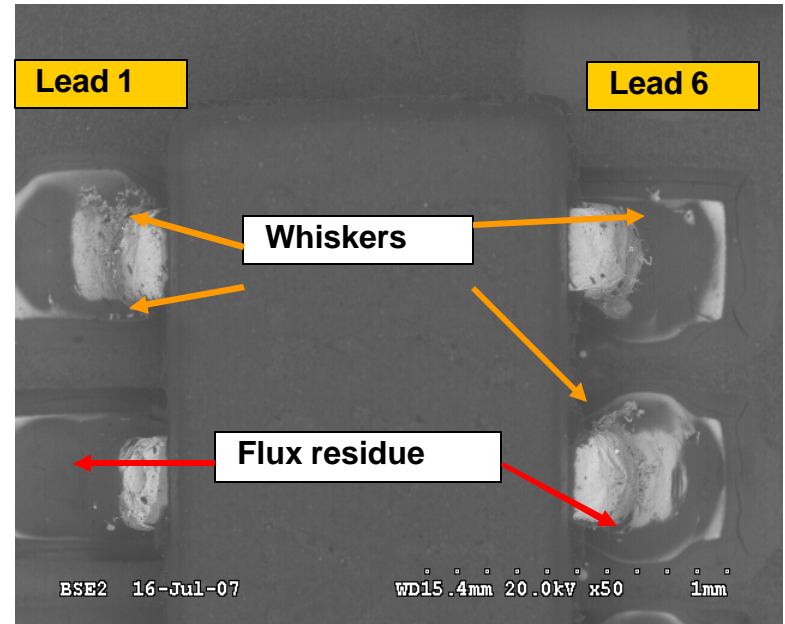
SEM, 50X

- Many whiskers and hillocks
 - Protruding through flux residue, and
 - Growing from solder without flux residue

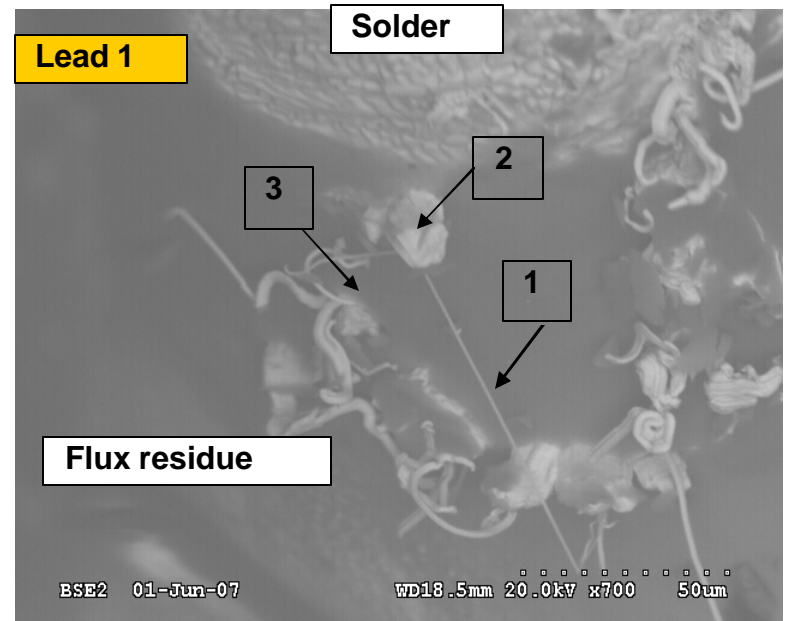
SEM, 700X

- The whiskers and hillocks with different sizes
 - Thin long filaments (1),
 - Thicker and shorter rods (2), and
 - Hillocks with no preferable size in any of three dimension (3)

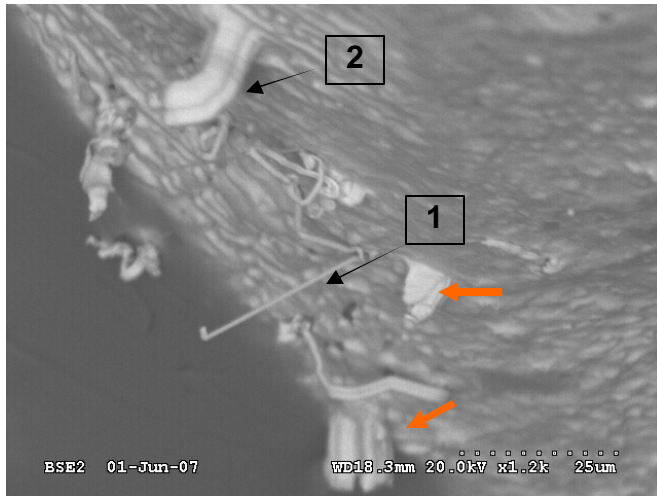
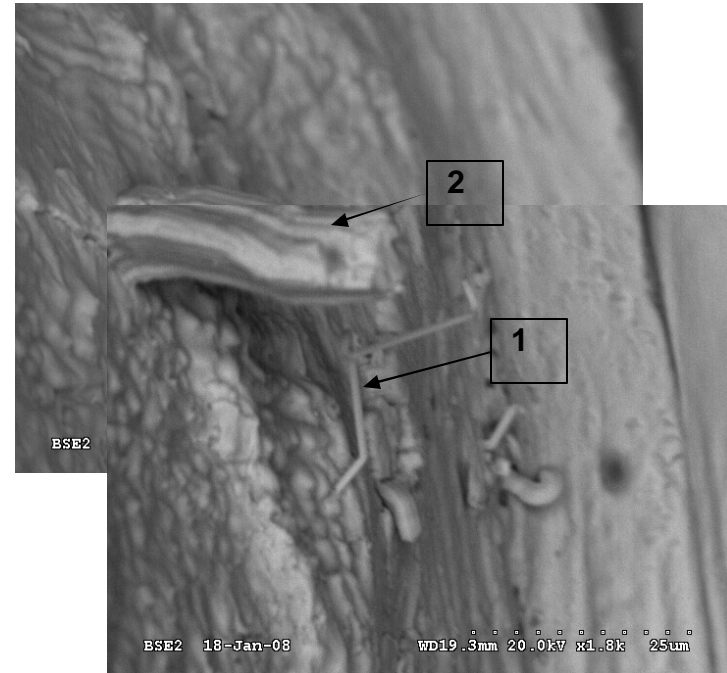
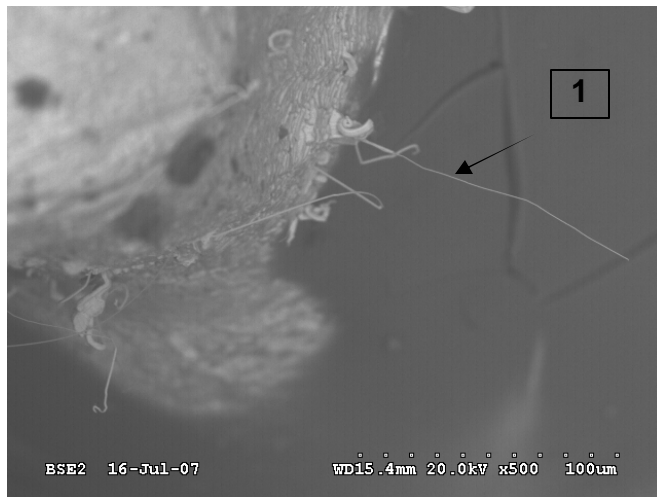
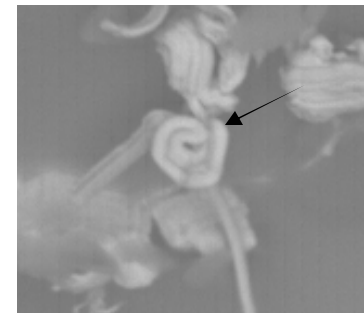
- Whisker shape:
 - Straight, kinked or hooked
 - Some consist of two connected rods often separated at the top
 - A spiral shape found
- The length of thin filaments varied
 - Short - 10 to 20 μm
 - Long - up to 140 μm
- The typical thickness
 - About 1.5 to 2.0 μm
- It appeared that thin whiskers often grew from hillocks
- Thicker rods usually had a striated surface which was not obviously visible on thin whiskers

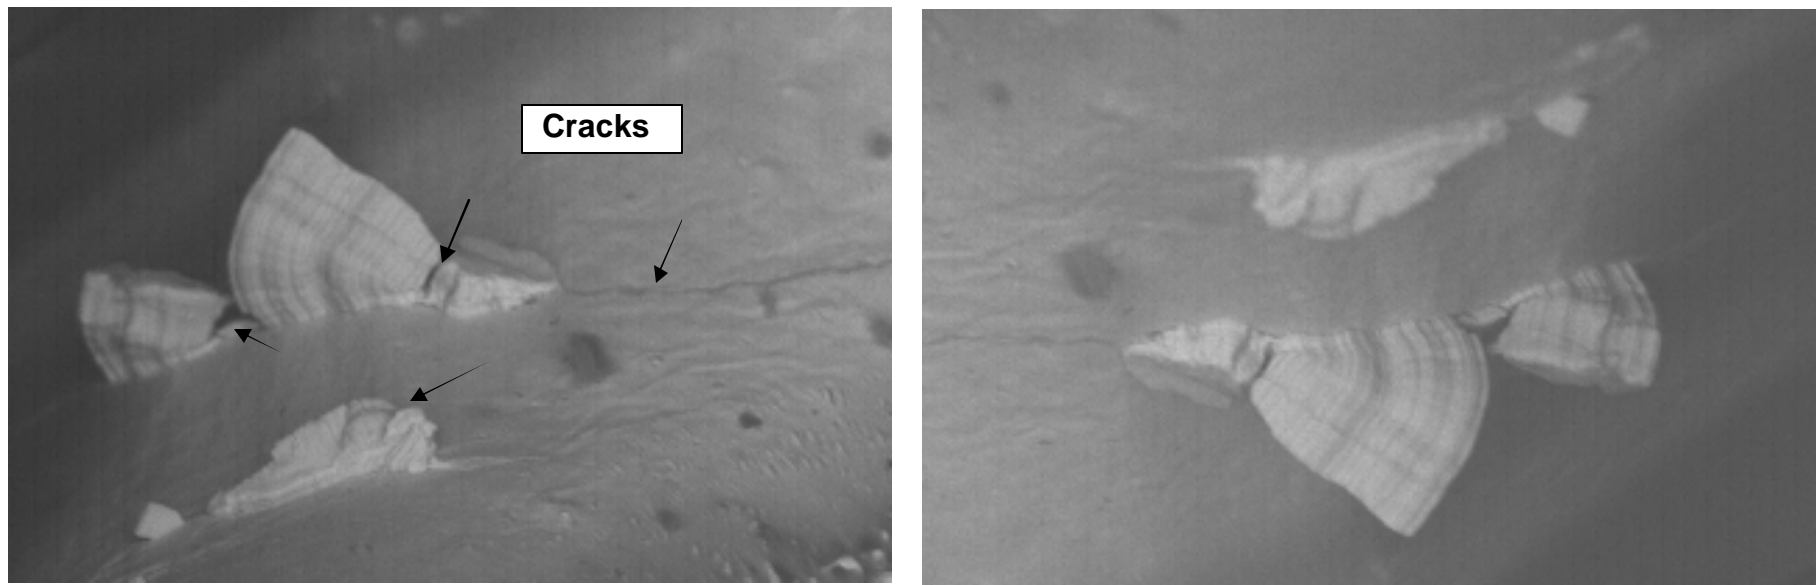
SEM, 450X

- Protrusions looking like thin shells
- Grow from a crack in the surface layer that may be an oxide or crystallized flux film
- Clearly visible striations in two directions
 - The stripes parallel to the edges of the shells
- Cracks in protrusions following the vertical striations

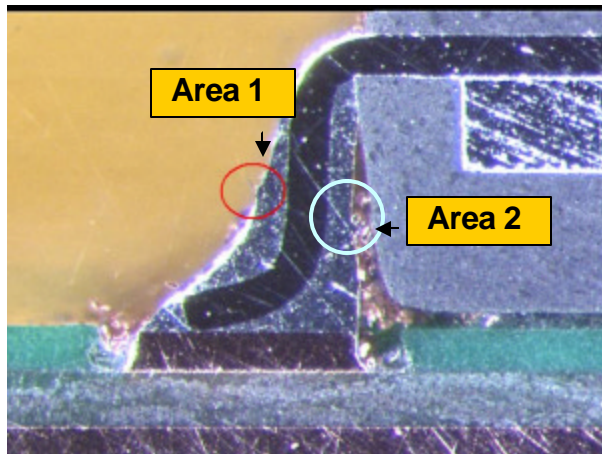
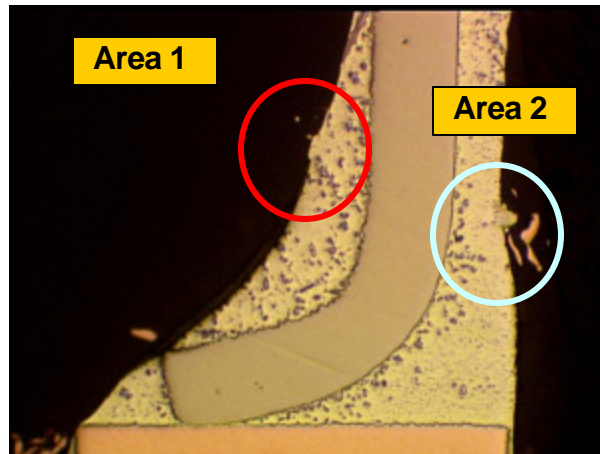
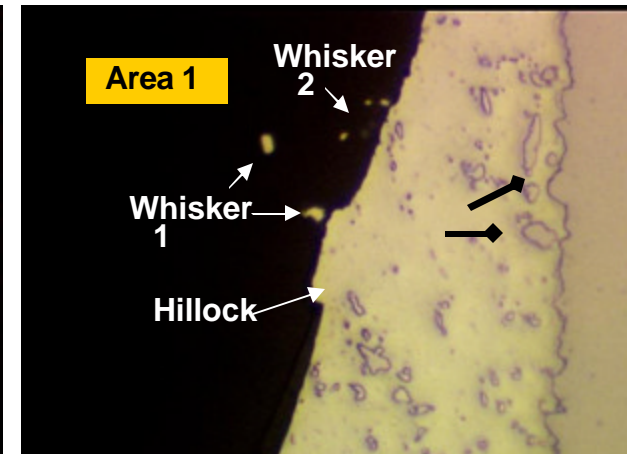
- Cross-section of selected locations with whiskers following by progressive polishing
 - Longitudinally and perpendicular to the leads
- The locations from which whiskers or hillocks started growing were targeted
 - In each polishing step, a layer 1 to 2 μm was removed
- Whiskers and hillocks were found at both toe and heel sides of the cross-sectioned lead

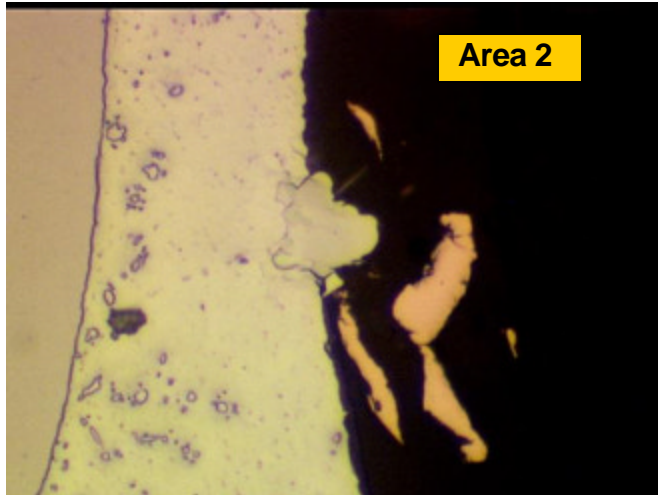
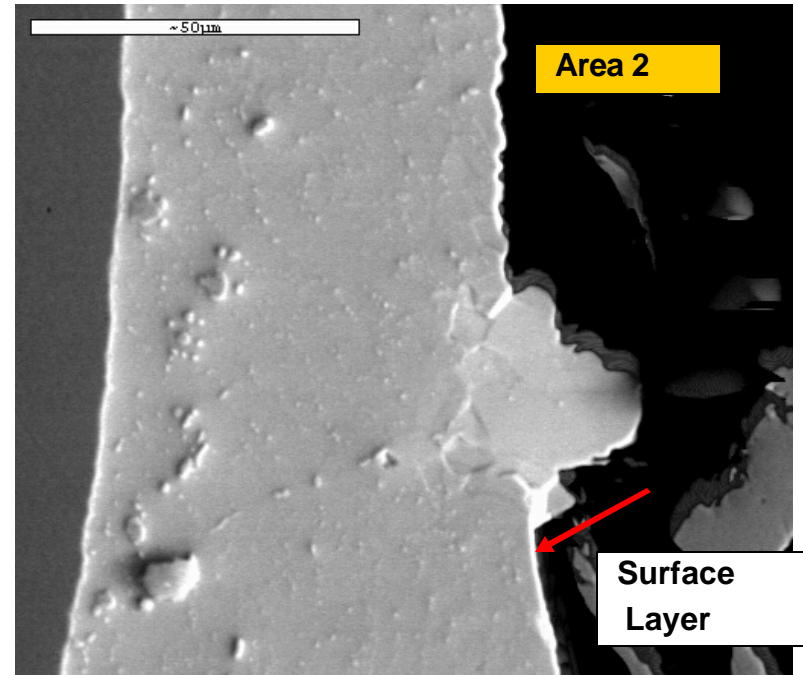
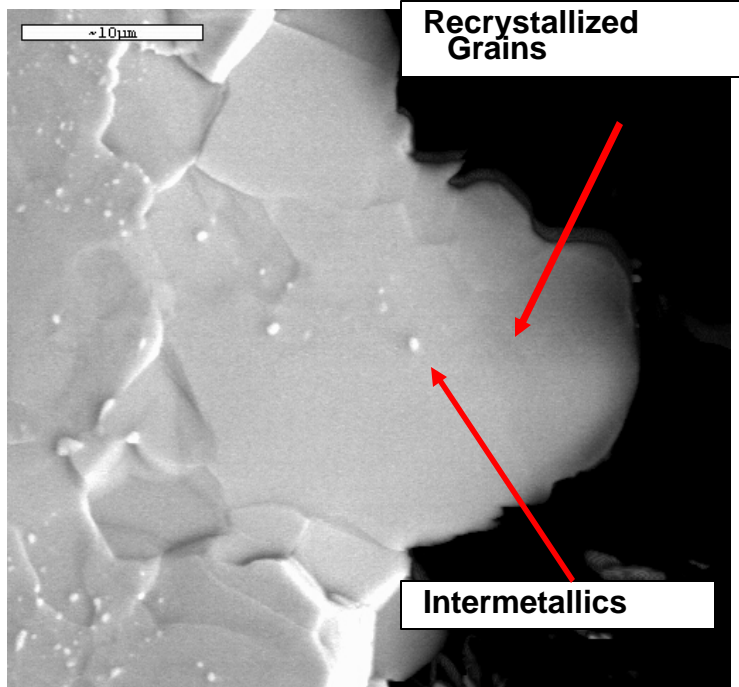
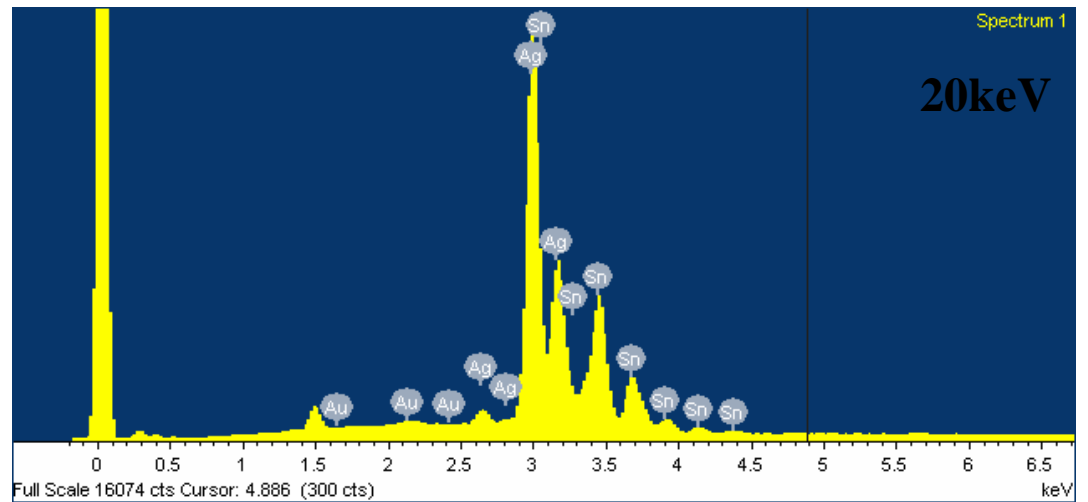
- Different from the bulk solder microstructure
- Contains the recrystallized Sn grains and
- Very few intermetallic particles
- It seems that the hillock emerged through the hole in a surface Sn oxide film
- The intermetallic particles are distributed non-uniformly and located only in the centre of the hillock
- The intermetallic particles contain either Ag or Cu in addition to Sn
- The rest of the protrusion is pure Sn
- It is possible that the solder was depleted of Ag and Cu by extensive diffusion caused by oxidation or corrosion
- The recrystallized grain size is smaller at the base of the hillock than in the hillock itself

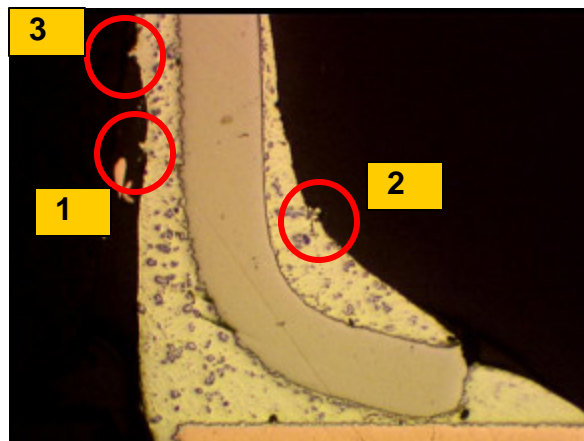
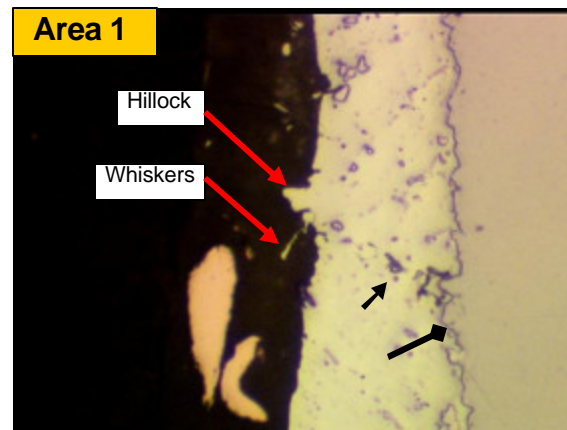
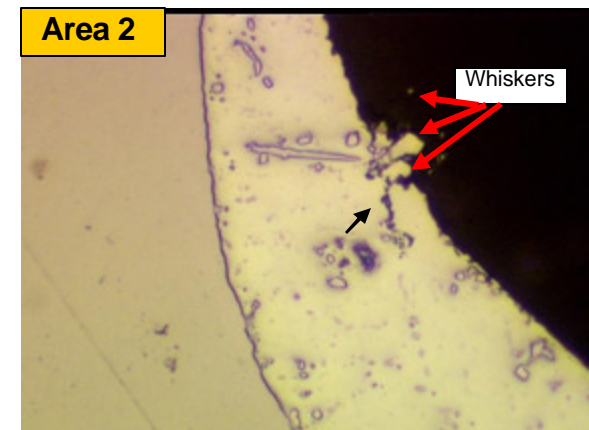
- Co-existence of voids with hillocks and whiskers
 - The corrosion channels are traceable to large outgassing voids
 - The voids are often related to the rough interface
- Corrosion channels near the rod whiskers or hillocks
 - Propagate through the eutectic structure in spaces between the dendrites' arms and have a dendritic shape
 - In some cross-section planes, they look like separate voids, but sequential polishing shows that they are always connected

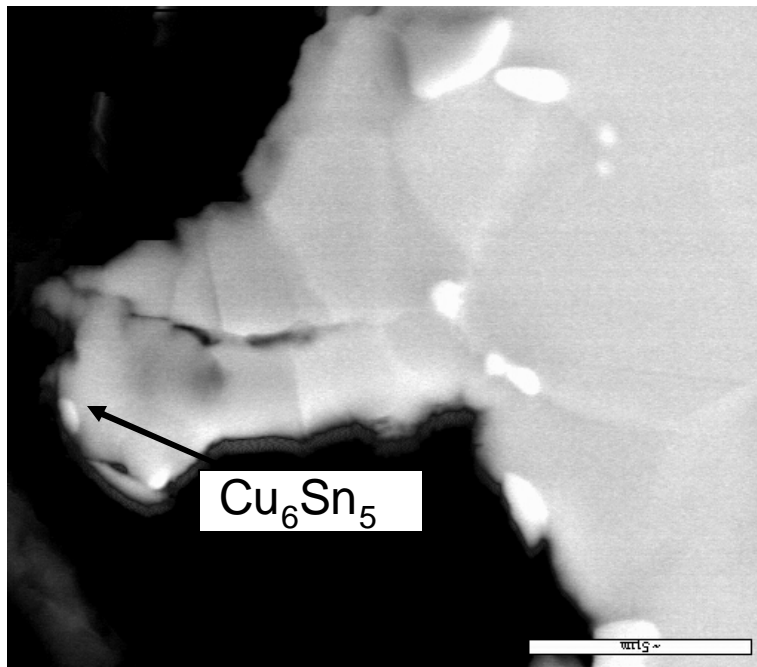
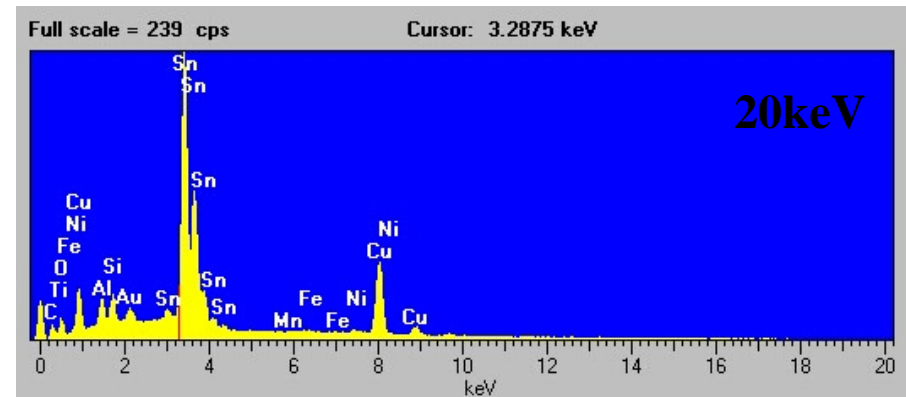
SEM, 7,000X

- The rod whiskers have features similar to the hillocks
- Grow from recrystallized solder
 - Depleted of Ag and Cu and
 - Containing much less intermetallic particles than the bulk solder
- Have recrystallized pure Sn structure
- May contain Cu_6Sn_5 and/or Ag_3Sn particles

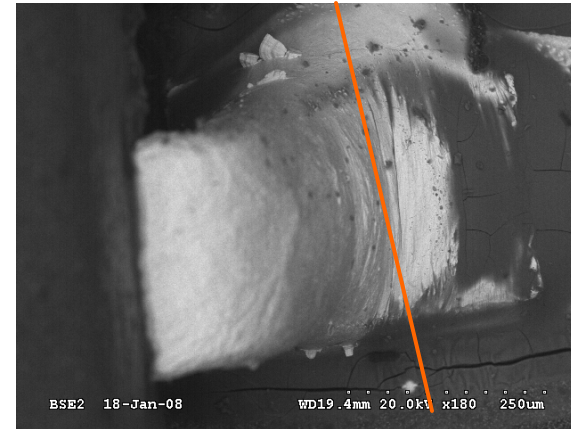
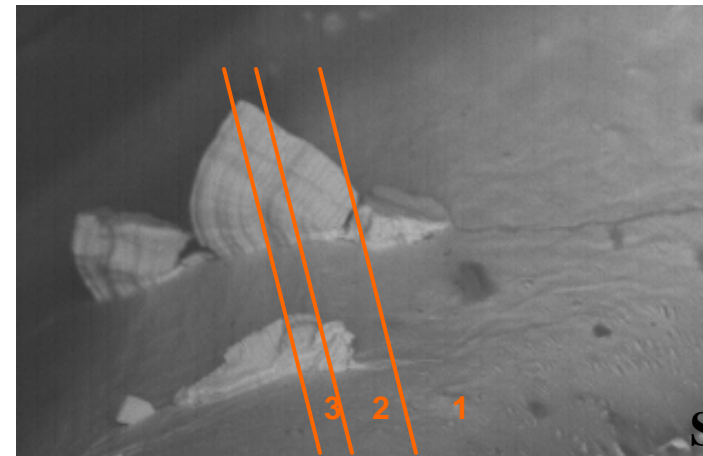
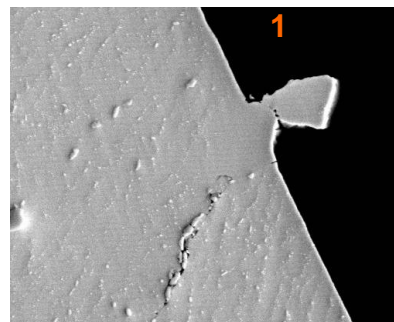
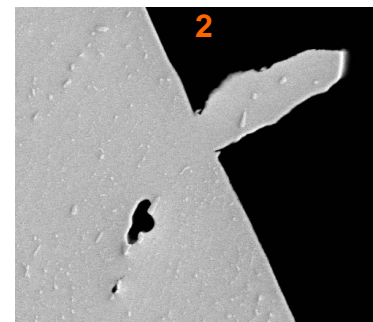
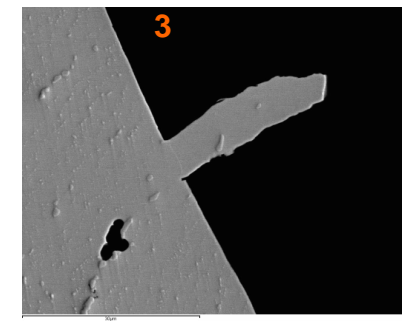
- The shell-like protrusions have a similar microstructure to the hillocks
 - Sn matrix with very few Cu_6Sn_5 and/or Ag_3Sn particles
- The two-dimensional striations are evident as
 - A surface roughness at the edges of the protrusion and
 - Stripes in the parallel direction
 - Black lines or wrinkles
- The cracks look like a separation between the grains

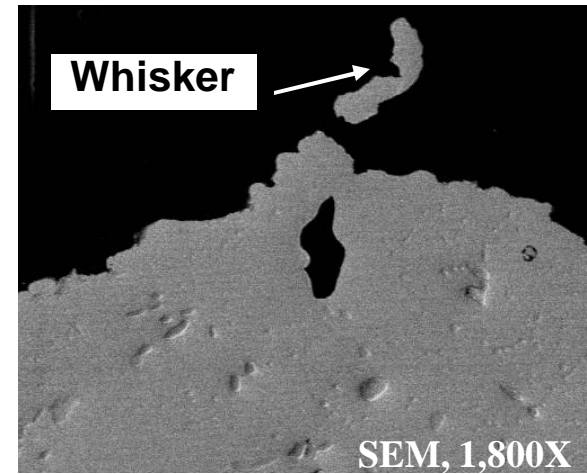
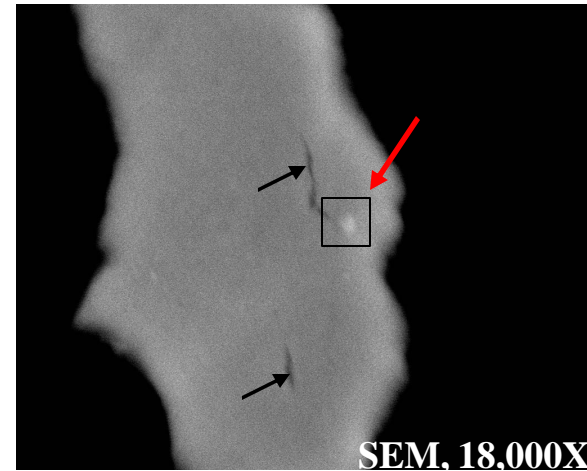
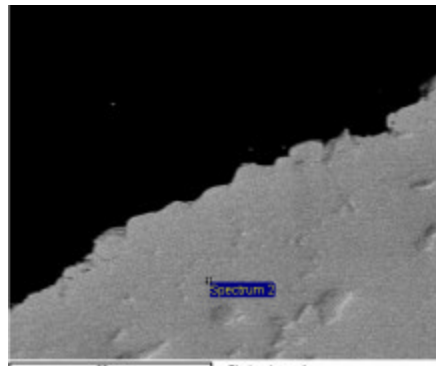
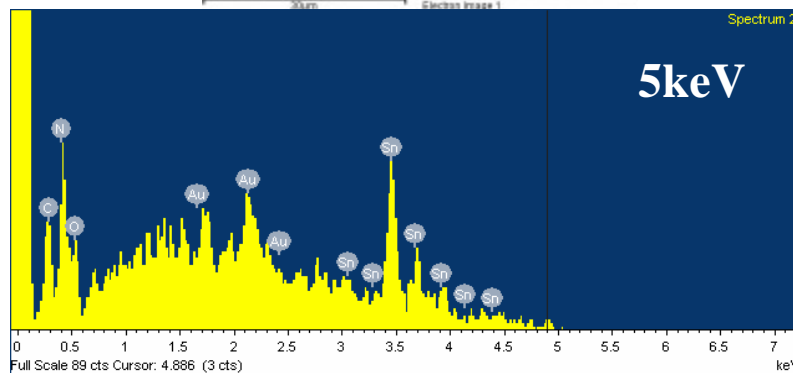
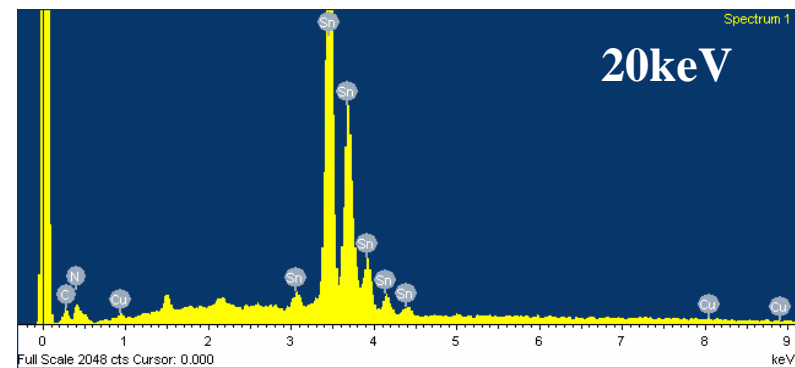
- N is present in
 - Corroded interdendritic spaces and
 - In the Sn matrix as well
 - Bulk solder and
 - Hillocks and whiskers
- The N peak is more pronounced using lower voltage, but still detectable under 20 keV

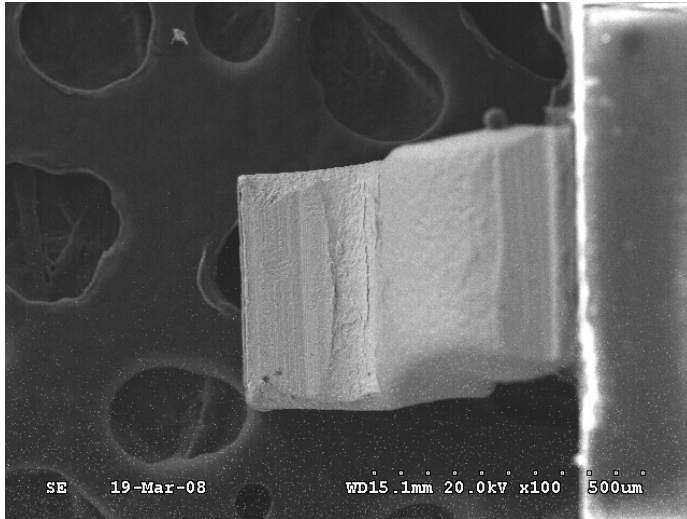
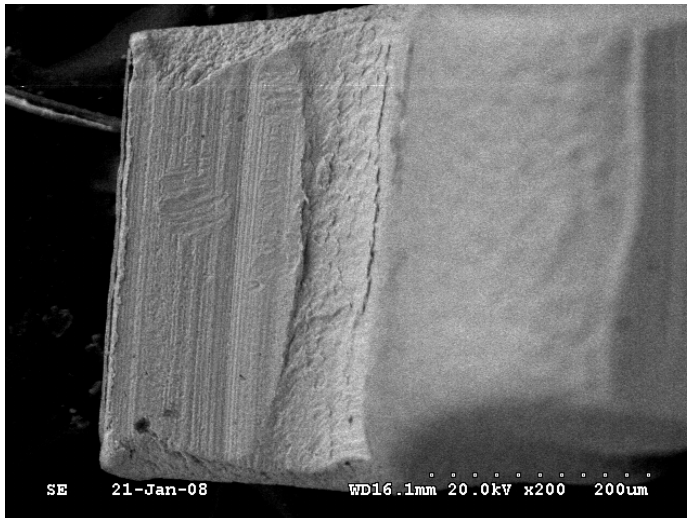
Good

- Difference in plating shape: Bad components have a double layer structure

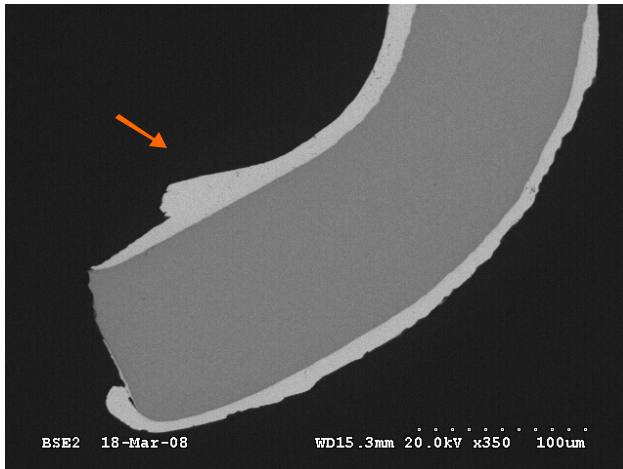
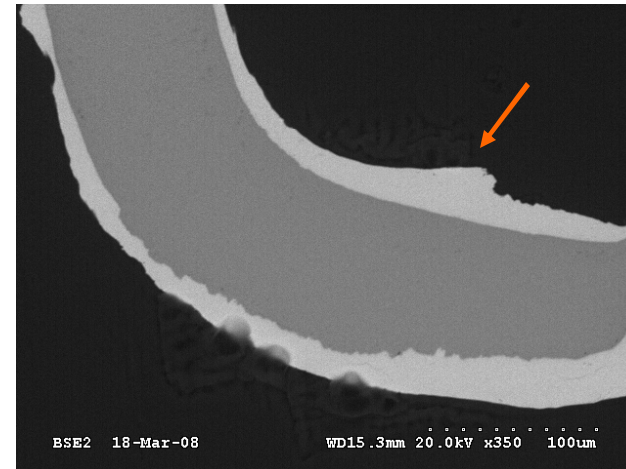
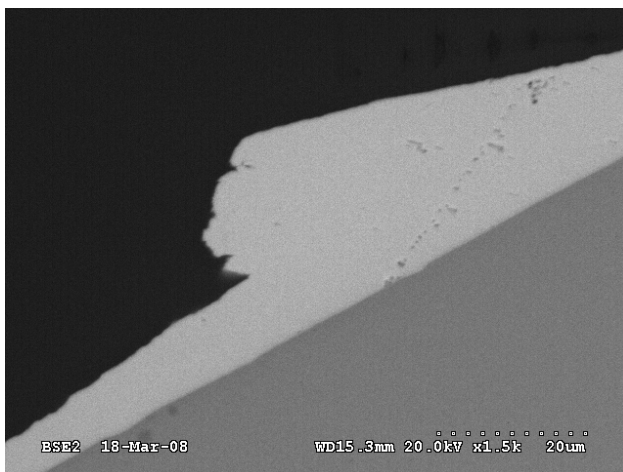
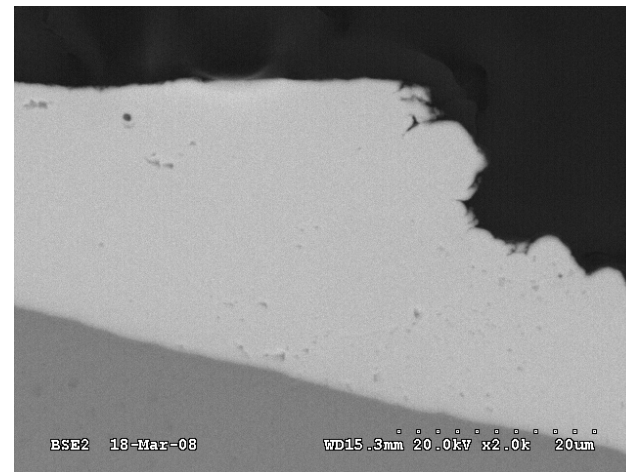
- Cross-sectioning confirmed the non-uniform thickness of the leads in Bad devices
- The thickness of the Sn layer varied from lead to lead
 - Average - 15 μ m to 24 μ m

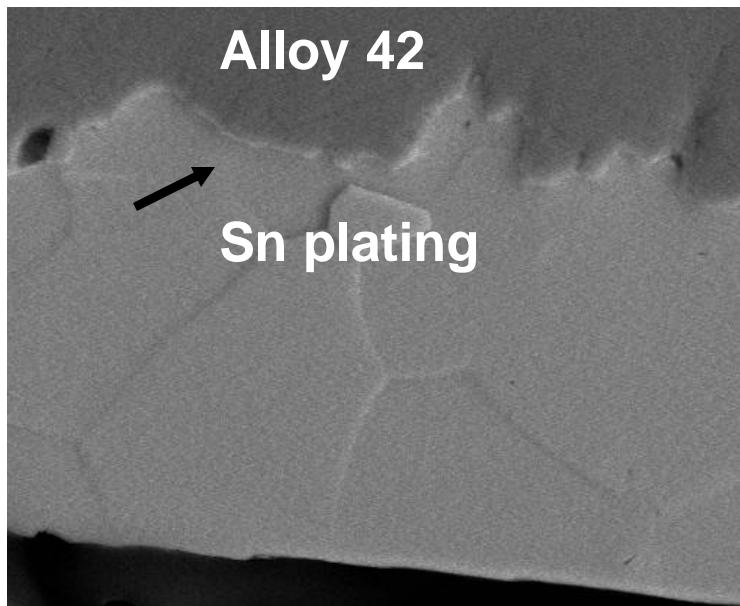
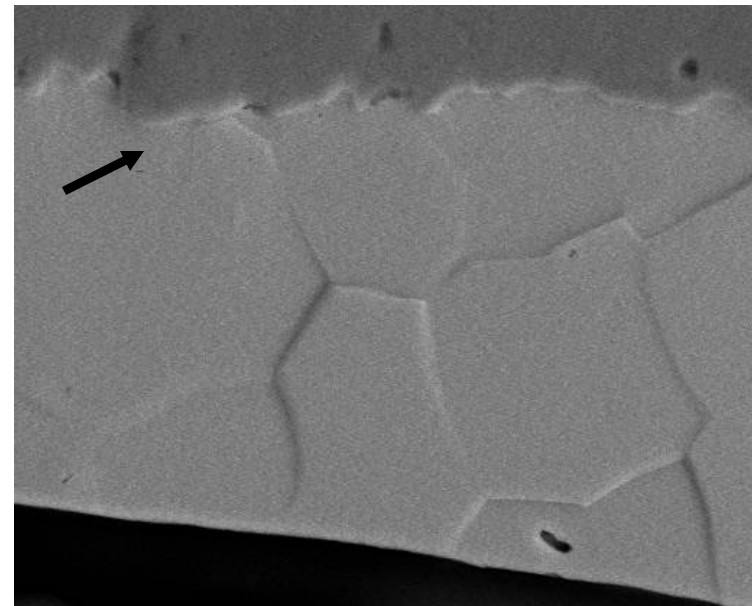
SEM, 6,000X

- The interface between the leads made of Alloy 42 and the bulk solder is rough
- Such an interfacial roughness is not normally seen
- May be a characteristic of a surface preparation before Sn plating

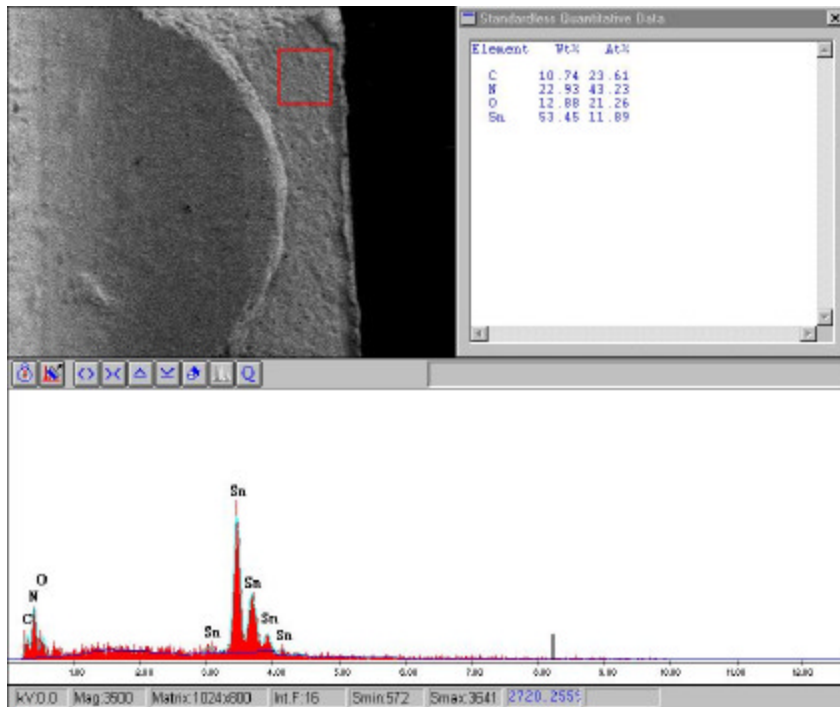
Bad

- Any area of the leads covered with electrolytic Sn contains N
- The lowest concentration - 32 At % (10.3 Wt. %)
- The highest content - 43 At % (22.9 Wt. %)
- The component bodies do not contain N

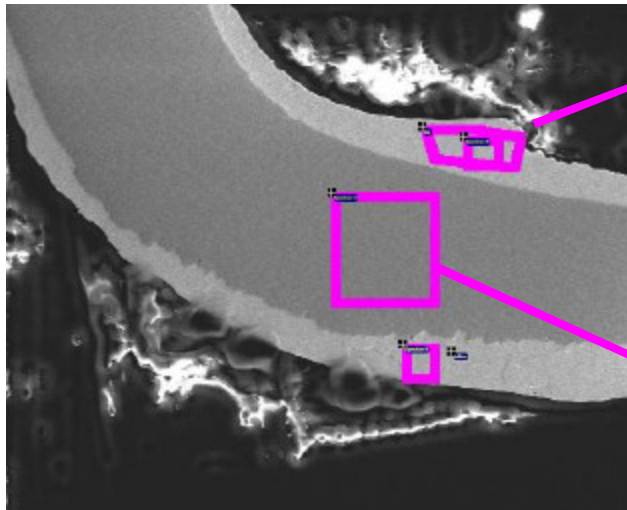
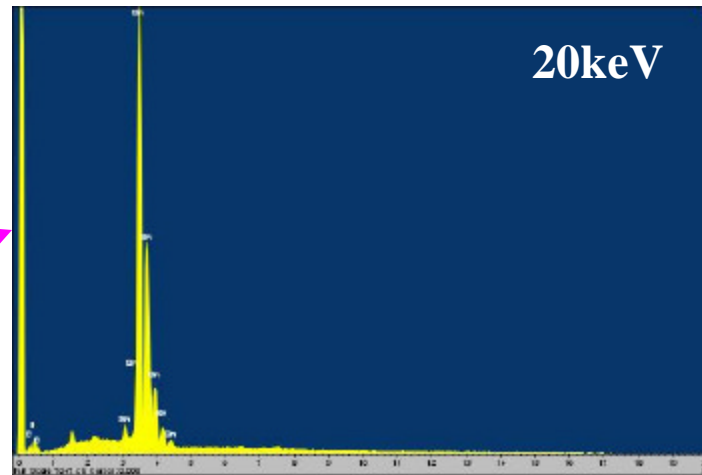
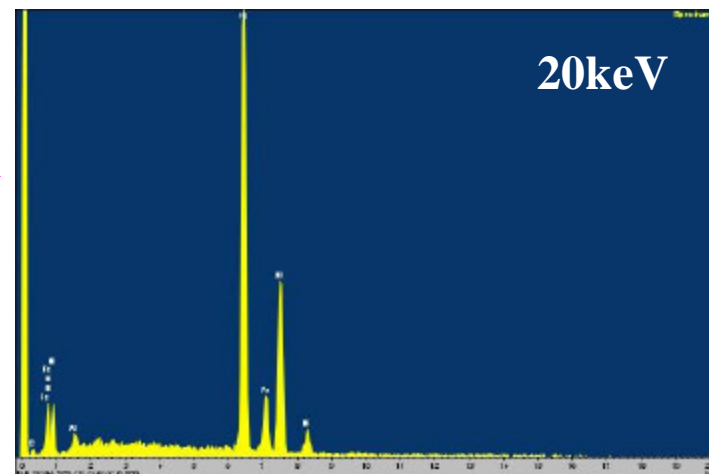
- In cross-sections of the virgin components,
 - N was found in the Sn plating
 - No N in the Alloy 42 lead-frame
- The thicker the Sn layer, the more nitrogen the solder inherits due to the higher gross amount present
