Electrical Failure of an Accelerator Pedal Position Sensor Caused by a Tin Whisker and Discussion of Investigative Techniques Used for Whisker Detection

5th International Tin Whisker Symposium

Failure Analysis of 2003 Camry APP Sensor

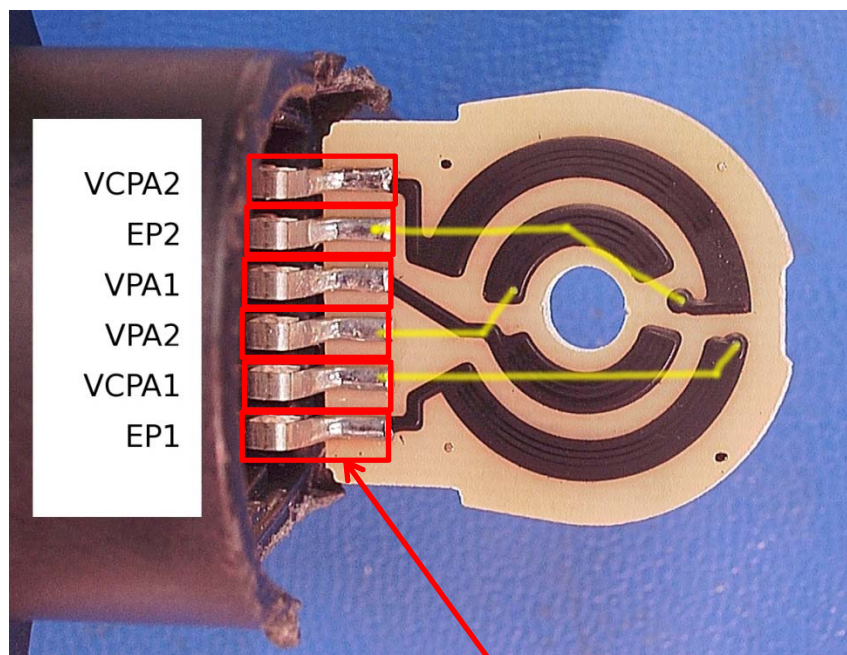
Tin-plated Cu alloy

- Ribbon Leads are a Copper Alloy Coated with 2 μm of Pure Tin
 - Confirmed by XRF & EDS
- No other coatings present on Ribbon Leads (i.e., no conformal coating over them, no intermediate plating layers)
- Separation between adjacent terminals varied from 1000 to 1500 μm
- Dual potentiometers produce independent electrical signals based upon pedal depression angle (VPA1 and VPA2)

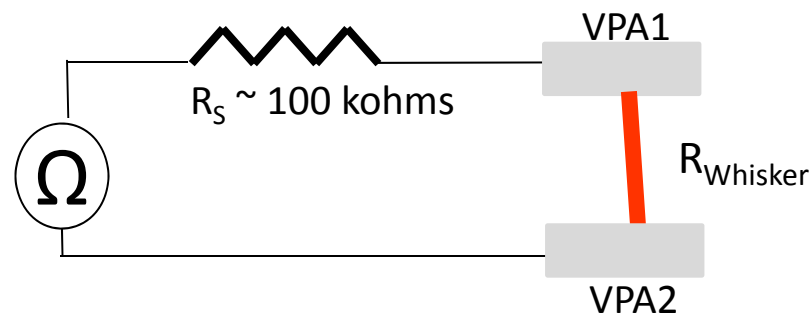
- APP sensor brought into the parts analysis lab at Goddard for further analysis
 - Intermittent resistance behavior confirmed
- Disassembly methods chosen to preserve evidence of conductive debris
 - Plastic housing removed without delivering shocks or introducing debris
 - Shorting resistance was continually monitored using a Fluke 87V multimeter in series with a $100\text{k}\Omega$ protection resistor, and shown to remain at 238Ω throughout disassembly, except for several excursions to “open circuit” ($>50\text{M}\Omega$) followed by return to about 238Ω

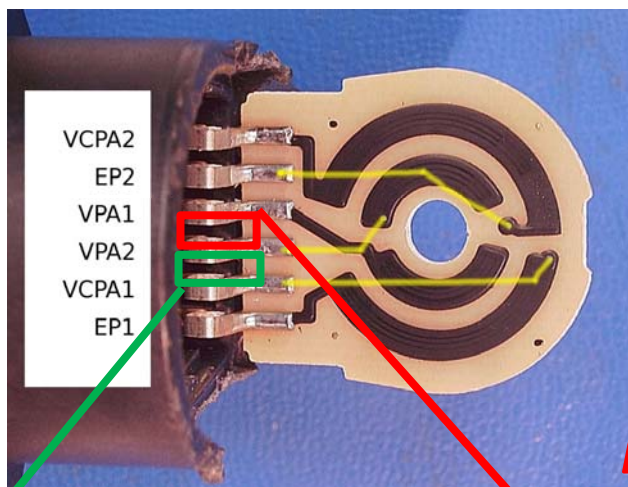
The Two Longest Tin Whiskers Observed in Faulty 2003 Toyota Camry APP Sensor

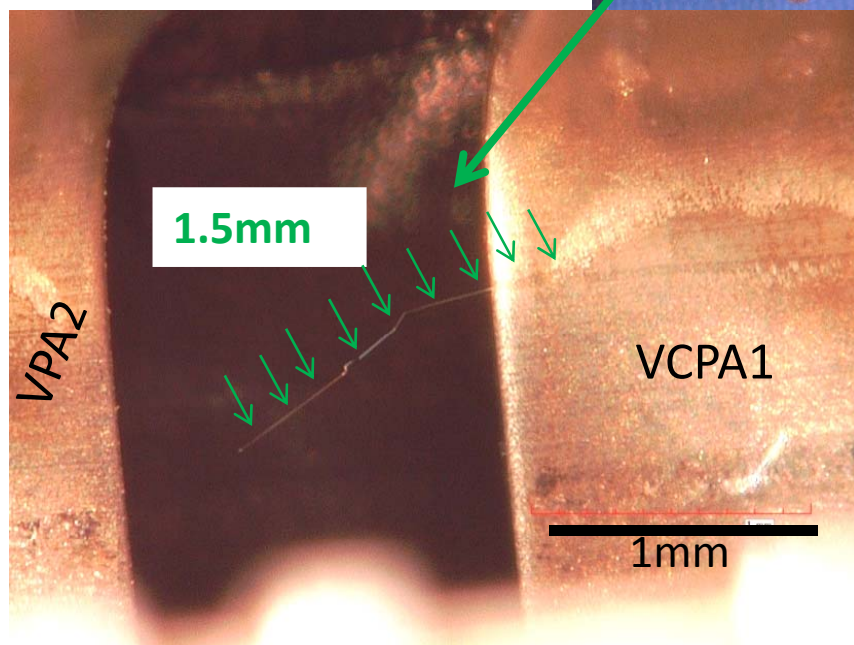
Tin Whisker Almost Bridging Between VPA2 and VCPA1

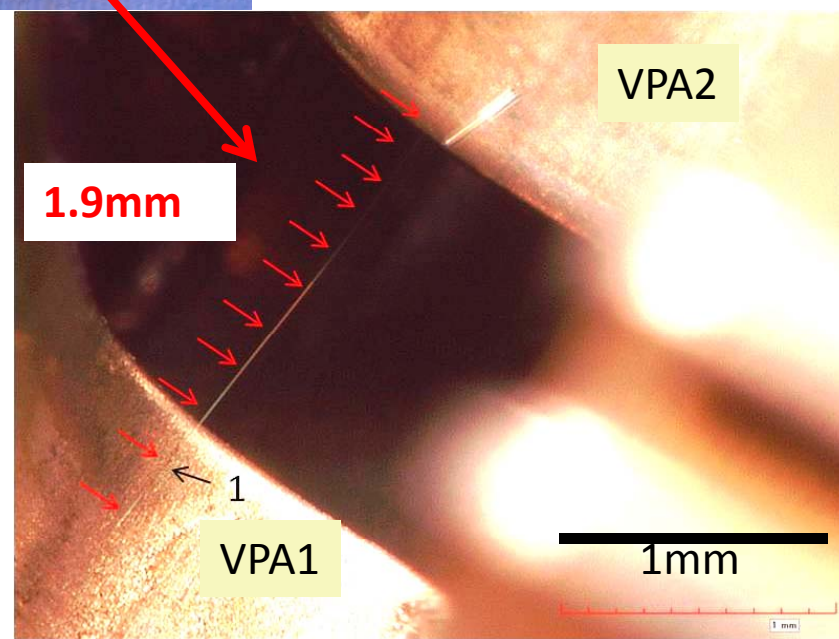
Tin Whisker Shorting Between VPA1 and VPA2

Calculation of Thickness of the Bridging Whisker from Measured Resistance and Length

- Therefore, since L= 1900 μ m, R = 238 Ω , then
d \sim 1.1 μ m
 - This is in line with typical thicknesses of tin whiskers

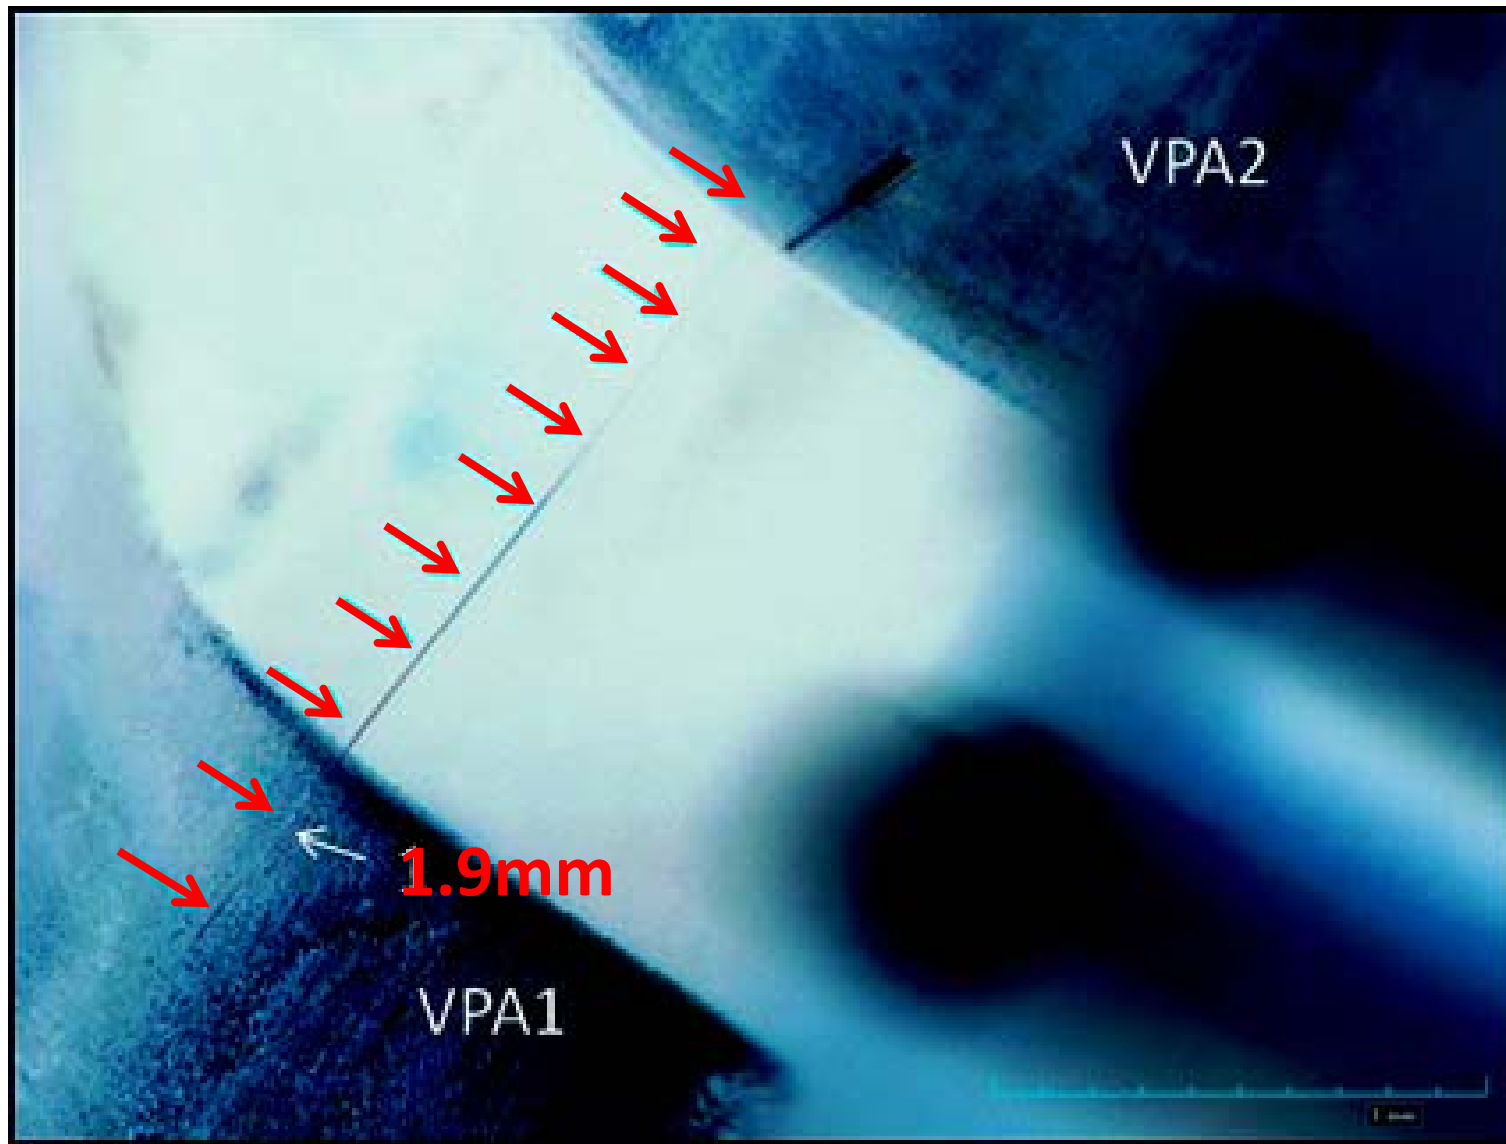
Whiskers in Faulty 2003 Toyota Camry APP Sensor

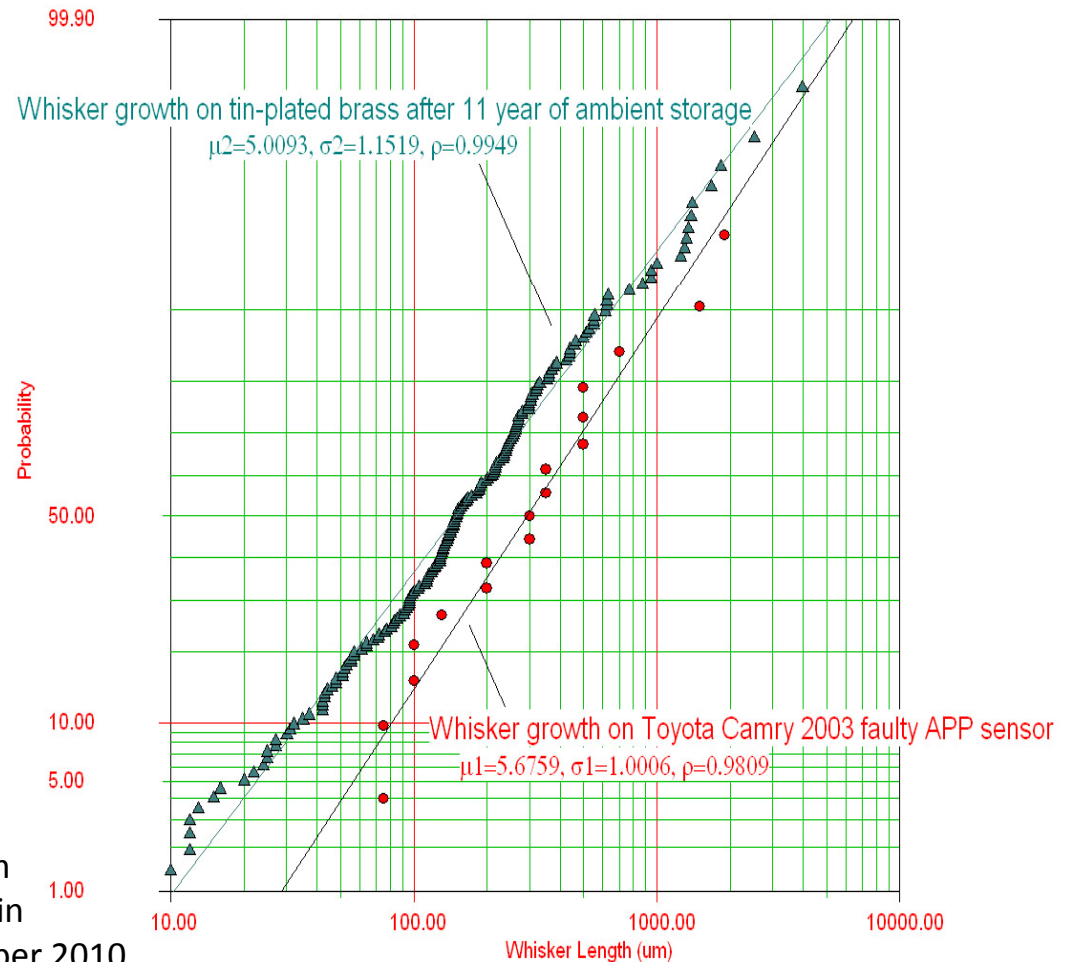
Whiskers $>50\mu\text{m}$ in Length found on the Faulty 2003 Camry APP Sensor

- 17 whiskers with lengths $>50\mu\text{m}$ were observed on the faulty 2003 Camry APP sensor
 - Whisker lengths on APP sensor may actually be longer than shown due to measurement technique
- Whisker growth seen on faulty APP sensor is not 'out of family'
 - Compare to whisker length data collected for tin-plated brass after 11 years of ambient storage*
