Relay Failure Caused by Tin Whiskers

Gordon Davy¹
Northrop Grumman Electronic Systems
Baltimore, MD

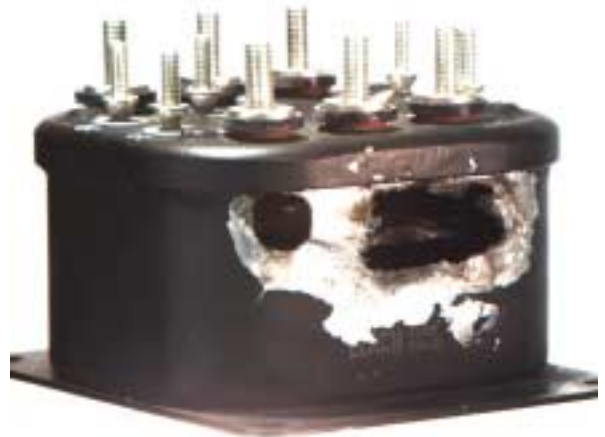
Figure 1 shows a failed relay. Soot on all surfaces can be seen through the hole in the case; the end of each terminal stud and the edge of the iron armature below each has melted. Removing the wall revealed that all six contacts² had melted open and that the edge of the armature³ had melted below each of the terminal studs. The discharge presumably initiated between one of the studs and the armature, and once started, it extended to the other studs and the case.

Figure 1 – Failed relay

Any relay containing tin plating inside is at risk of having tin whiskers. A whisker almost long enough to cause failure was observed in the unfailed relay. One whisker, if it gets long enough and is appropriately located, and if adequate voltage and current are available, can cause a damaging event of the kind shown in Fig. 1, even at atmospheric pressure.

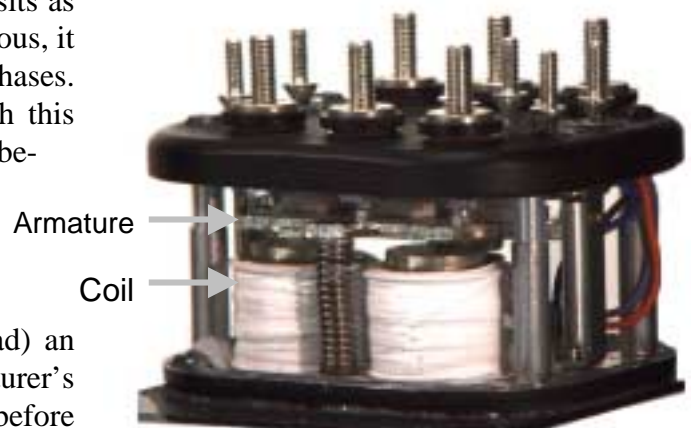
Figure 2 – Opened unfailed relay

Examination of a relay that had served in the same equipment as a failed relay for fourteen years (Fig. 2) but had not failed showed no arcing deposits (Fig. 3) except for slight darkening in the center of the contacts themselves (Fig. 4). The insulation resistance between phases and to ground was found to be far greater than the specified 100-megohm limit.

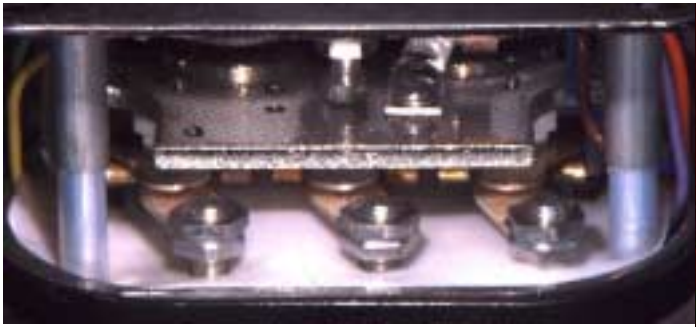
Figure 3 (above) – View of cut-open relay showing three contacts and sheet of Teflon insulation. Three (of six) contact pairs are visible directly below the armature. No evidence of contact arcing deposits can be seen.

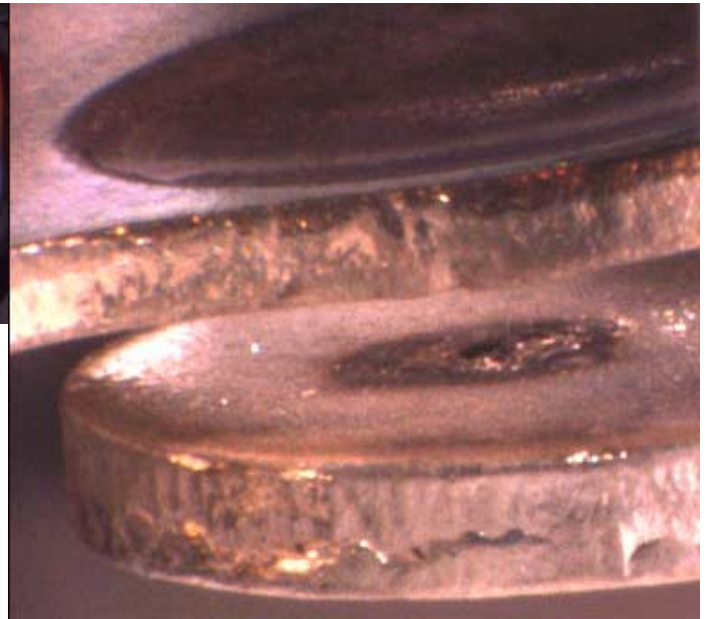
Figure 4 (right) –view of contacts showing lack of arcing deposits beyond the center.

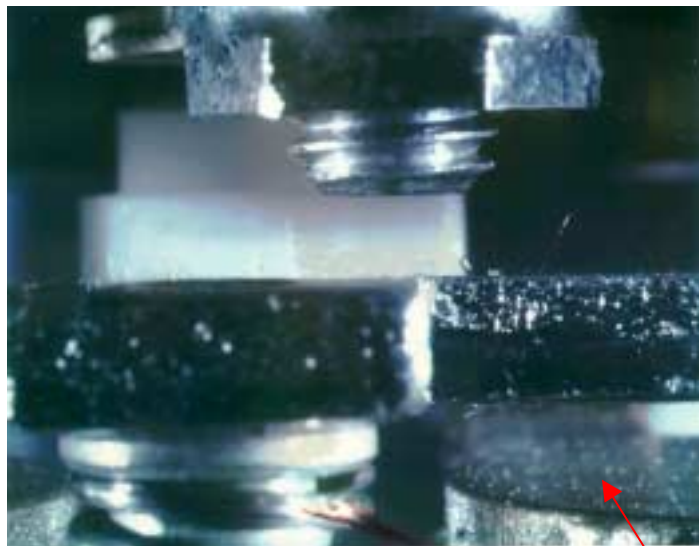
What became apparent upon opening the unfailed relay was the bright tin plating on the armature, including many long whiskers. X-ray fluorescence confirms that the armature plating is pure tin¹³. The wall plating is tin-lead¹⁴ and does not have whiskers.

Figure 5A – Edge view of armature with pole piece

Although with suitable lighting the whiskers can be seen without magnification, photographing them is difficult¹⁵. Figure 5 shows an edge view of the armature. A terminal stud is seen at the top, and the return spring at the bottom. Not visible in the photo is a whisker that spans about 75 percent of the gap to this stud. Many flattened whiskers can be seen as spots on the pole piece of the coil (see red arrow, Fig. 5A). For judging dimensions, the gap in Fig. 5B between armature and terminal stud is 0.07 inch (1.8 mm). Many whiskers longer than 0.1 inch (2.5 mm) can be observed, but (as to be expected) only at locations where the gap is larger. Figure 6 shows another view of whiskers.

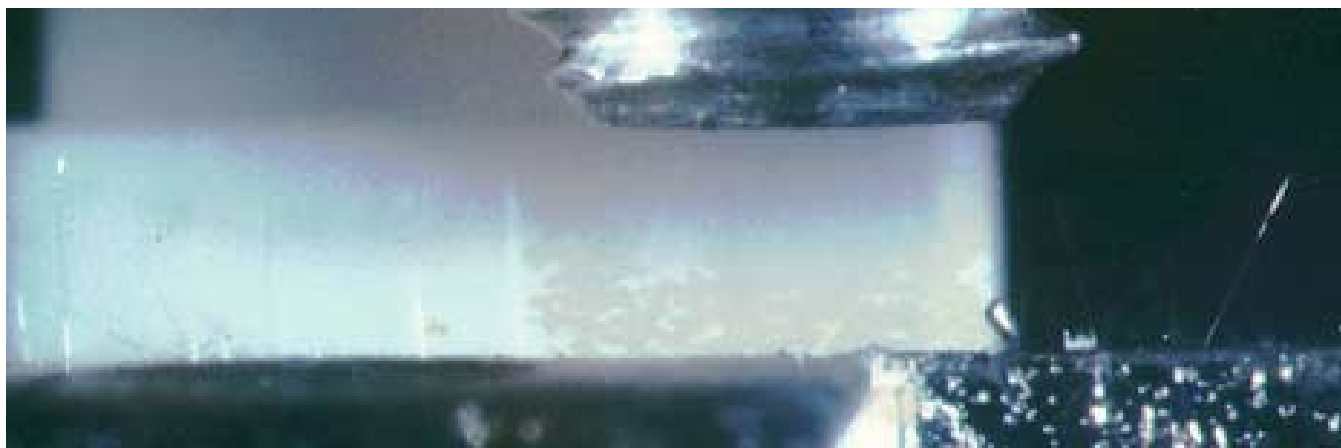
Figure 5B – Close-up view from Fig. 5A. Arrows show location of prominent whiskers

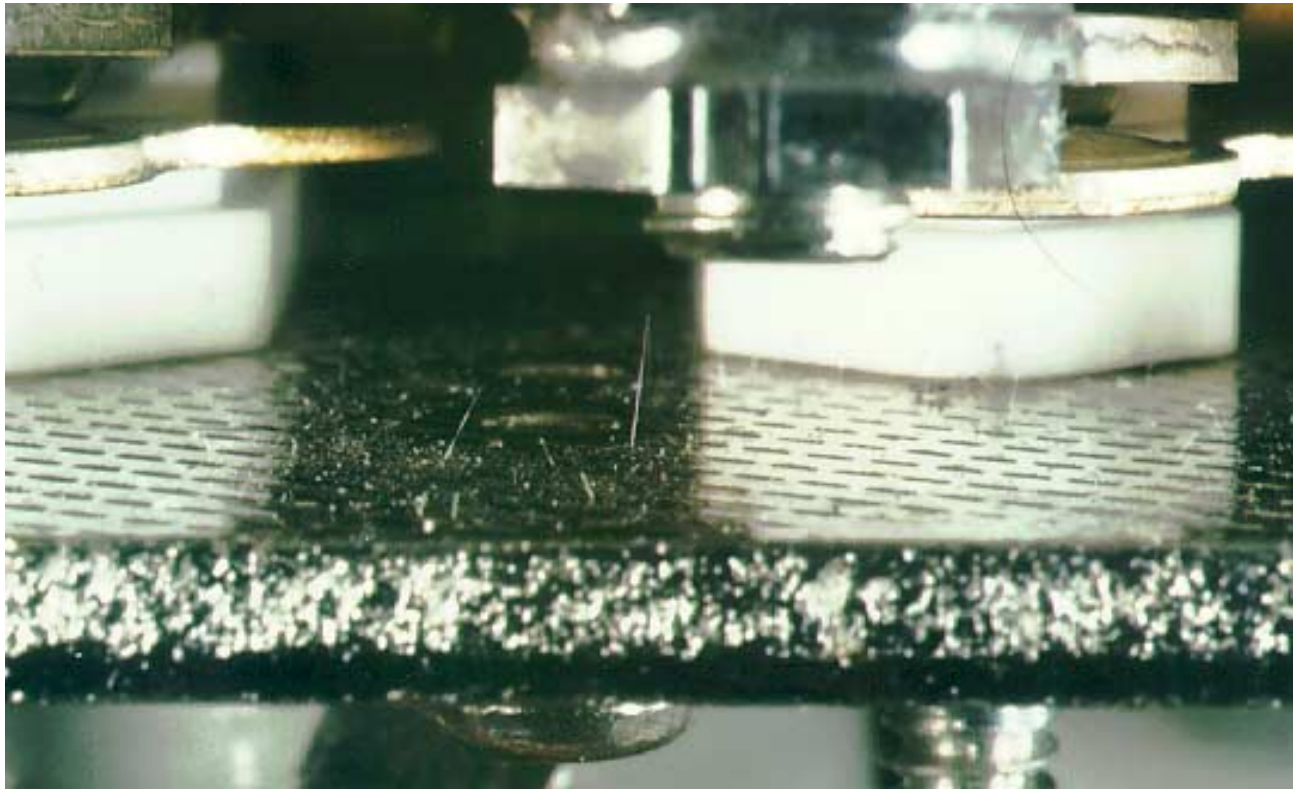
Figure 6 – Oblique view of armature showing whiskers
