Some Examples of
“Whiskers”
from
Tin-Based Alloys

Compiled by
Jay Brusse/Perot Systems
July 2009

Background

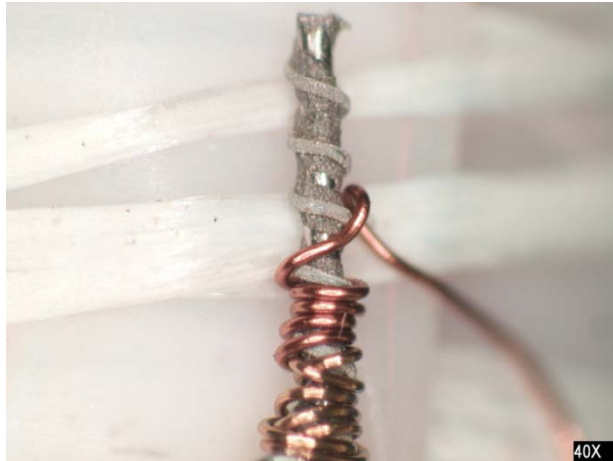
Whiskers from SnAg Eutectic Solder

- small diameter pure copper transformer wire is wrapped around a cupronickel pin and then soldered in place using SN 96 eutectic tin-silver solder.
- unit was exposed to unusually high temperatures over an extended period of time as a result of system failure unrelated to these whiskers

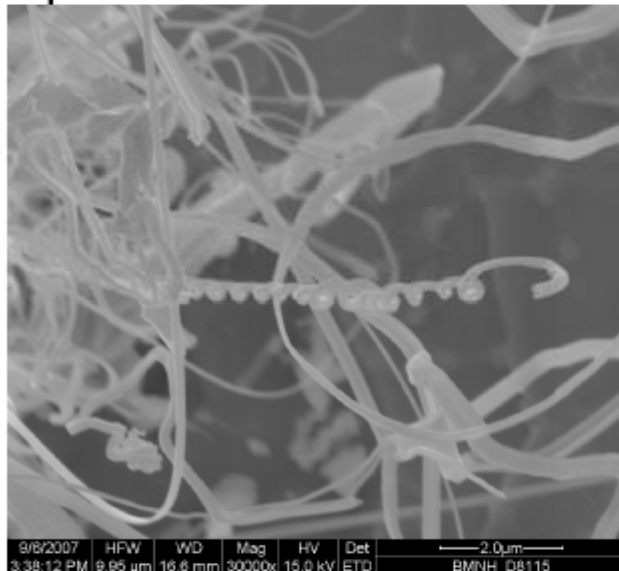
1. Spiral tin whisker and distorted tin whisker

Storage at room temperature in air for 720hr, on the surface of CeSn₃ phase

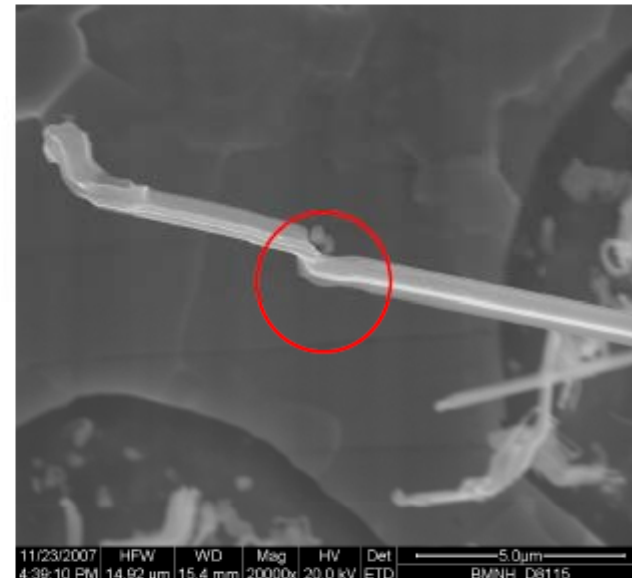
Storage at room temperature in air for 820hr, on the surface of CeSn₃ phase

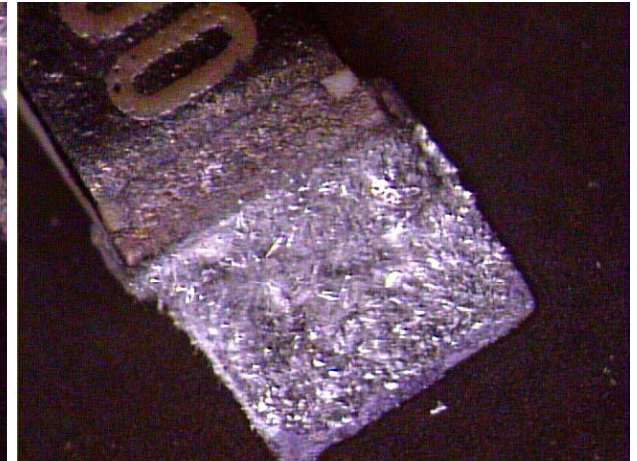
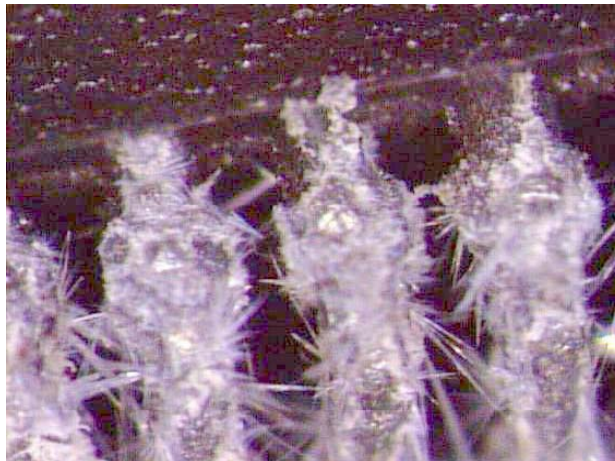
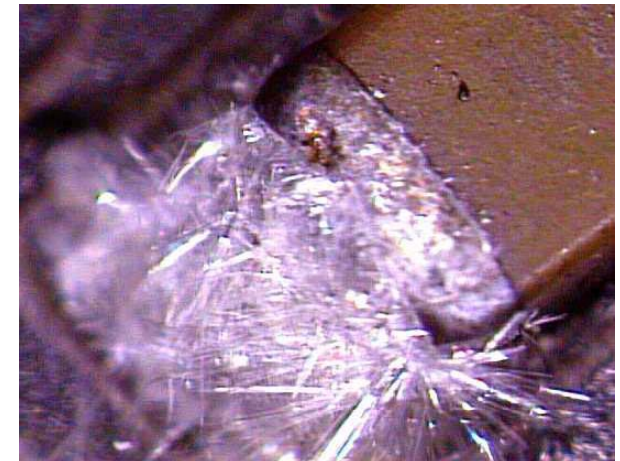
“Whiskers” or some other crystalline formations? on Sn95Sb5 solder joints after 200°C Storage Test

The solder used was Sn95Sb5 (MP 235oC), the unit was place in an oven at 200oC and held for 200 hours. The components were supposedly nickel tin plated gull wing, discrete resistors, capacitors of the 1206 size, connectors etc. The boards were polyimide with a final finish of electrolytic nickel (200microinches), palladium (8 microinches) and gold (6 microinches). The “whiskers” grew from the leads, and from the solder in large continuous patches that looked like a a field of crabgrass. Even the solder on the Ni/Pd/Au lands on the board grew whiskers. Also in the test were assemblies soldered with Pb85Sb10Sn5. This solder did not grow whiskers, but the leads did.

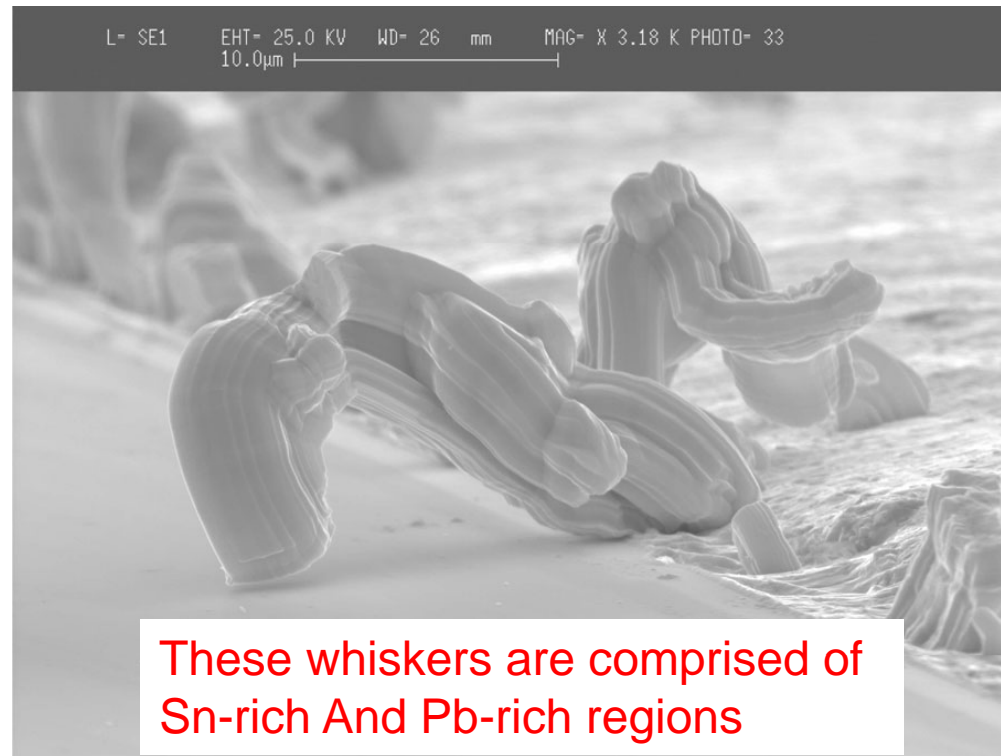
SnPb Whiskers Formed on Sn63Pb37 Reflowed Die Attach

- GaAs Laser Diode Array attached to Cu-W heatsink using Sn63Pb37 solder
- Current densities during operation $\sim 10^5$ Amps/sq.cm
- Shunting distance < 5 microns

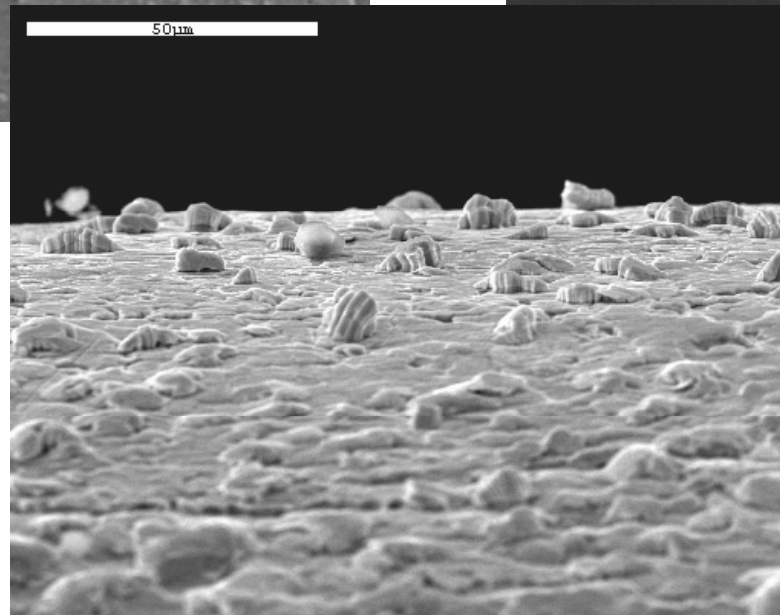
Sn-Pb Whiskers from Sn-Pb Coated Ceramic Chip Capacitor Terminations after Extensive T-Cycle

These whiskers are comprised of Sn-rich And Pb-rich regions
