Effects of Tin Mitigation Processes on Whisker Growth and Solder Joint Reliability for Chip and Small-Outline Package Components

*Northrop Grumman Network Communications Division
San Diego, CA 92128*

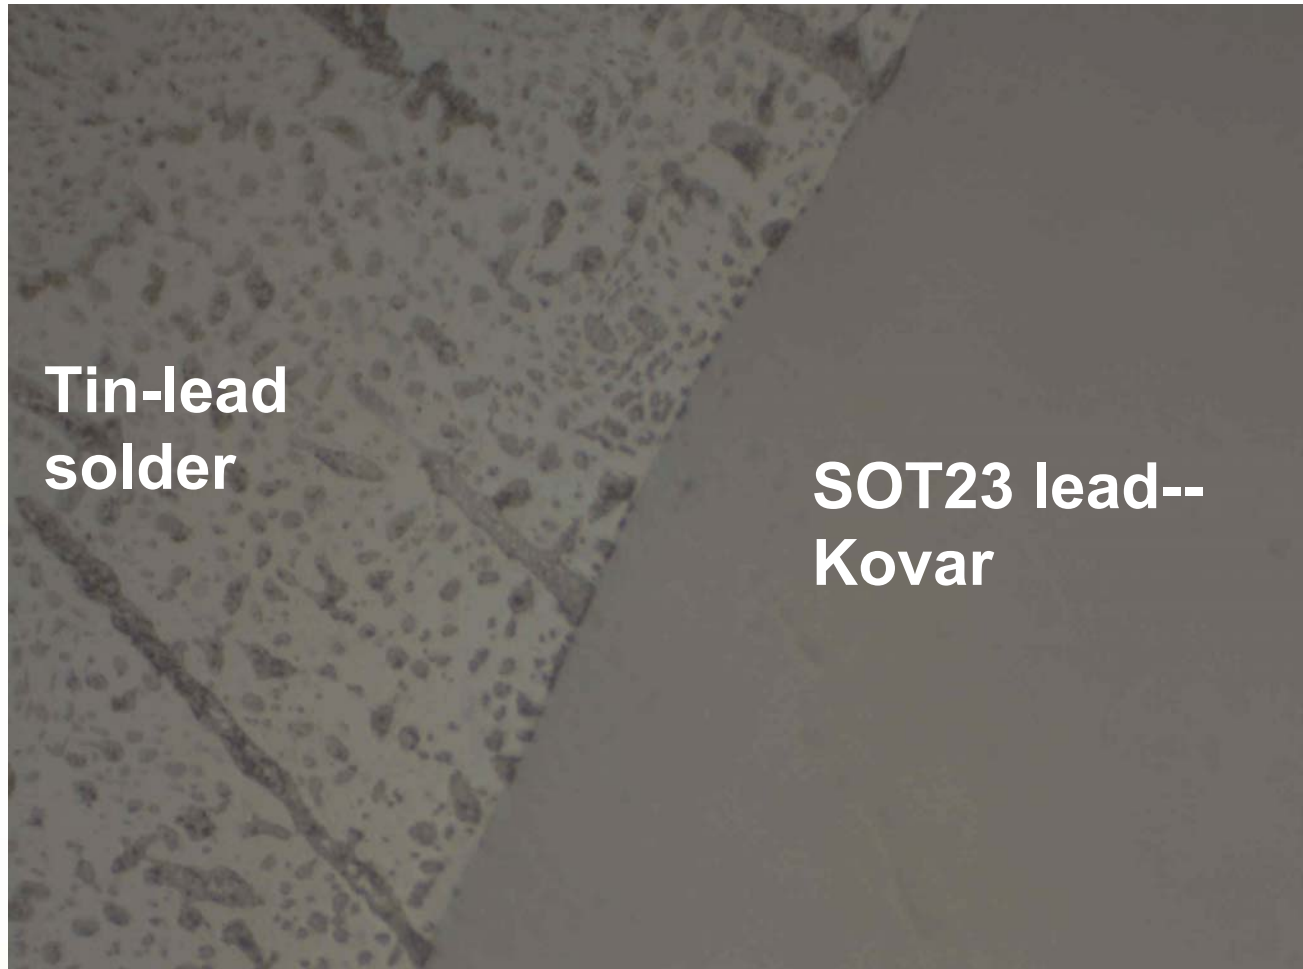
Tin-lead
solder

SOT23 lead--
Kovar

**Cross section of SOT23 lead after solder dip—
no perceptible residual tin**

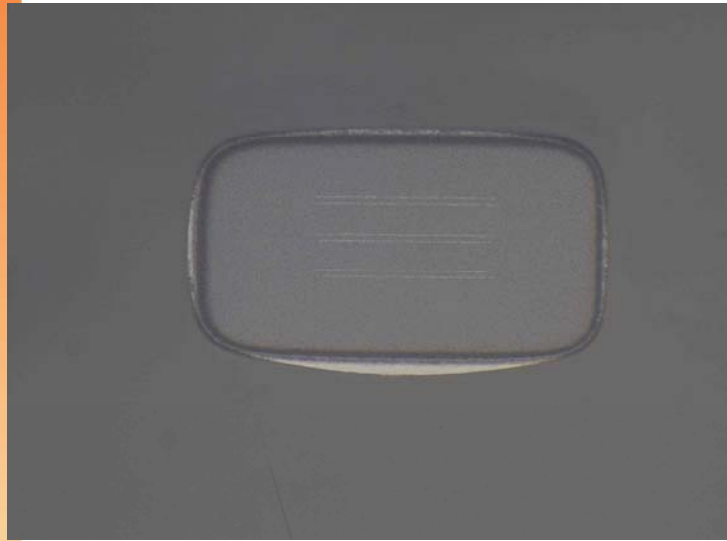
Cross section of ceramic chip part shows no cracks or damage to ceramic. Minimal solder coverage at corners—possible solderability issue

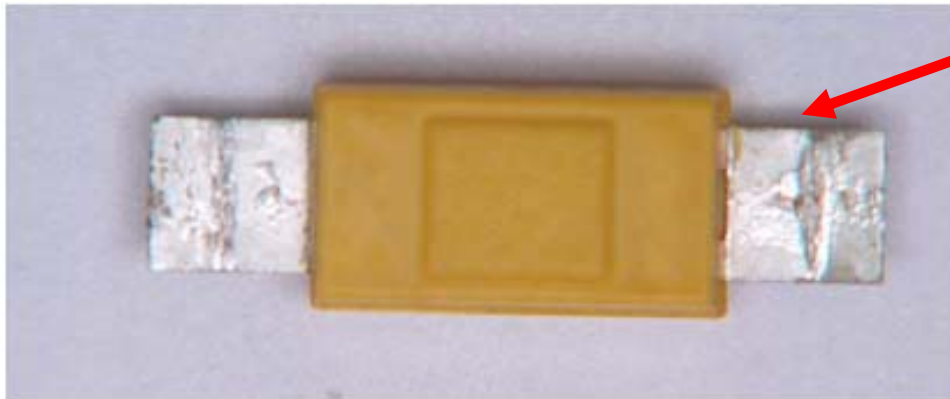
EDX analysis of pulled back
leads revealed that solder
dipped part had incomplete
solder coverage

Tin surfaces on wrap-around leads of “low profile” capacitors were not fully mitigated due to tight of space between lead & body
“Pb addition” process yielded Pb across all surfaces of leads

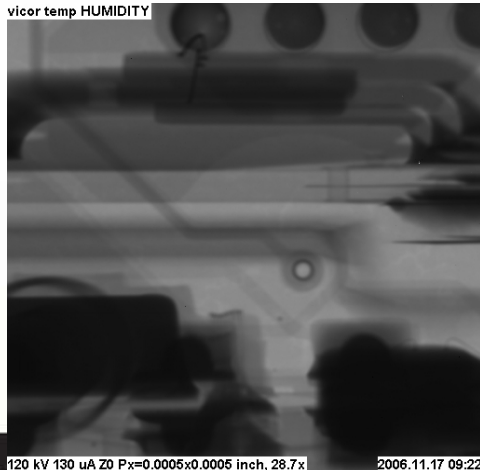
vicor temp HUMIDITY

120 kV 130 μA Z0 Px=0.0005x0.0005 inch, 28.7x 2006.11.17 09:22

- Encapsulated modules and reballed BGAs could not be visually or SEM inspected
- X-ray analysis was attempted to discern whisker growth, with resolution down to approximately 10 μm .
- No whiskers were detected; BGA solder balls looked OK
- Encapsulated modules passed electrical test.
- Ceramic-filled coating and encapsulation may inhibit proliferation of whiskers

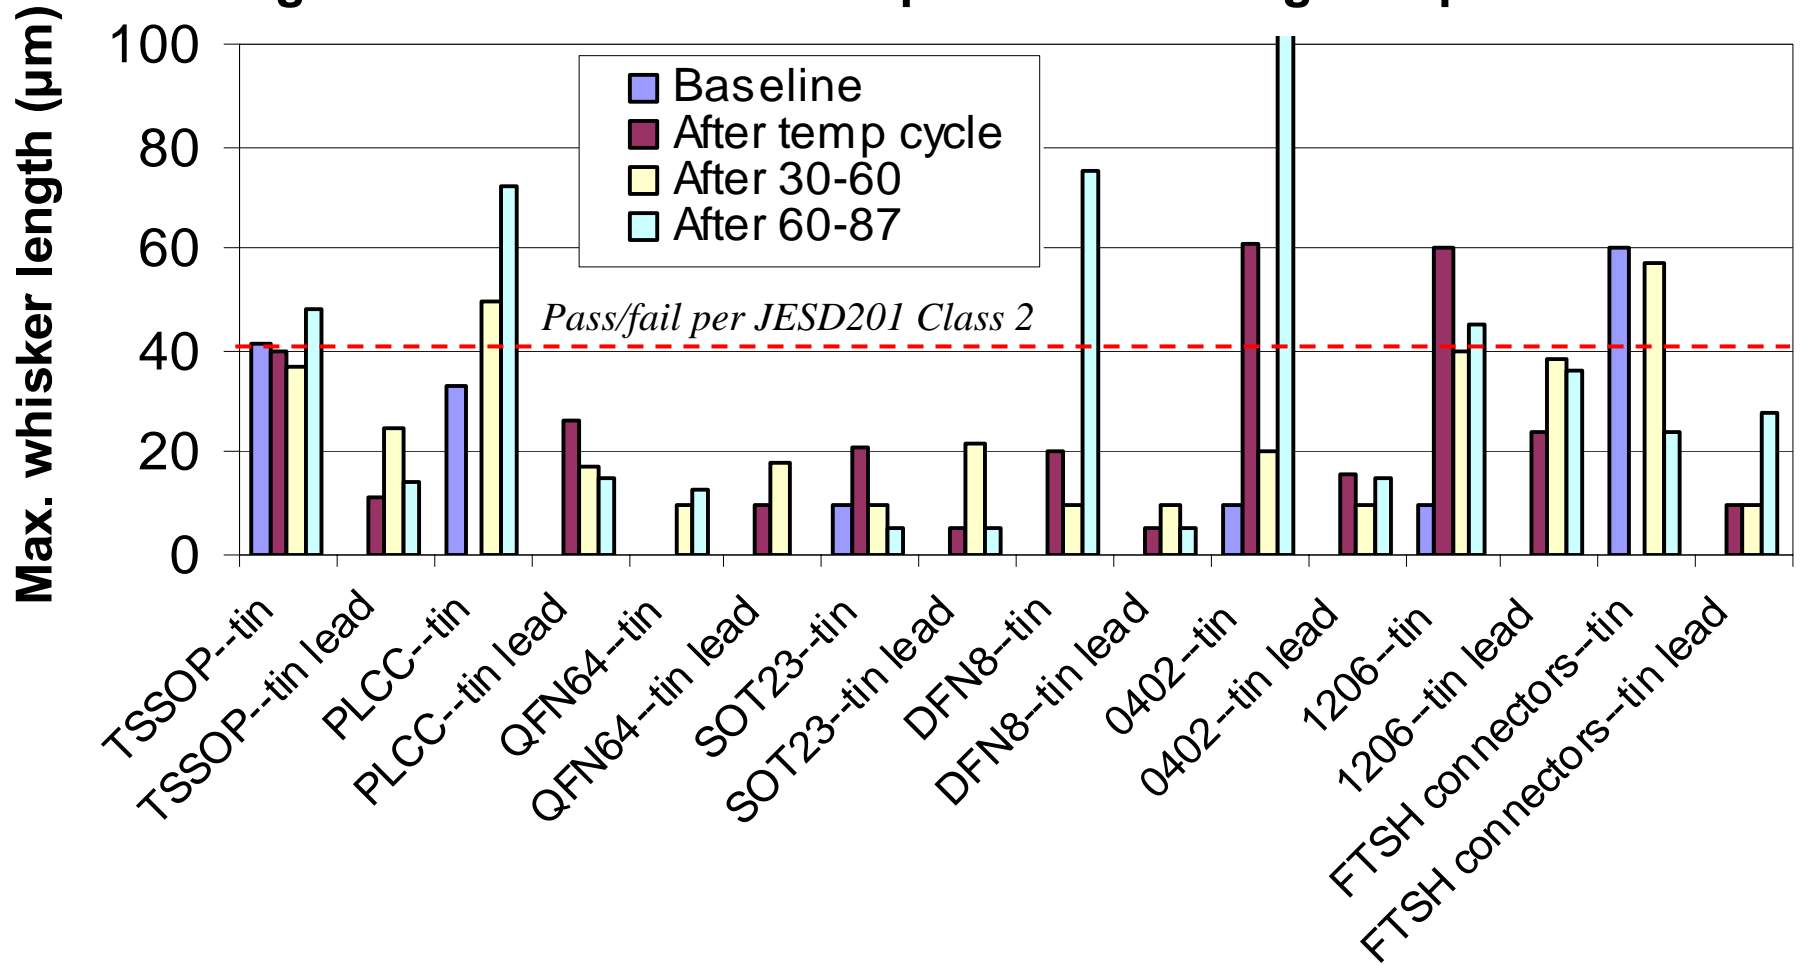
Fig. 3 Tin Whisker Growth--pure tin vs. mitigated parts

Tin mitigation greatly reduces but does not eliminate whiskers.

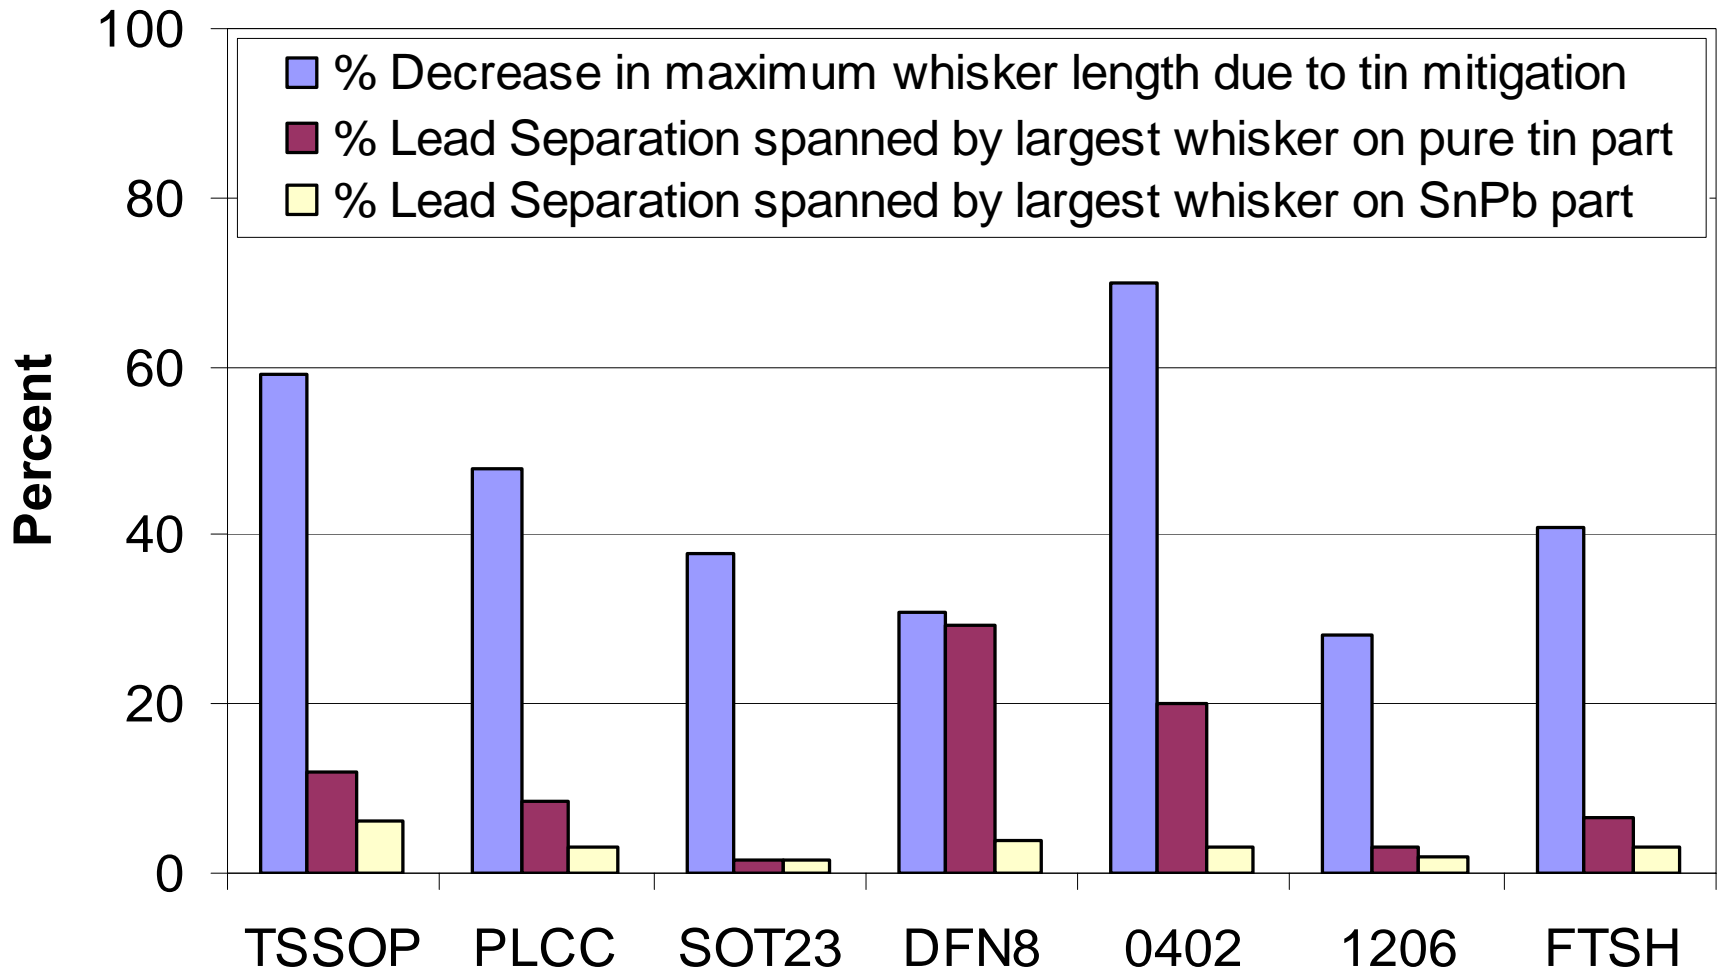
Fig. 4 Decrease in Whisker Size Due to Tin Mitigation & Span of Largest Whisker

Tin mitigation reduces length of whiskers by 3X to 15X

Largest whiskers spanned only 30% of span between conductors.

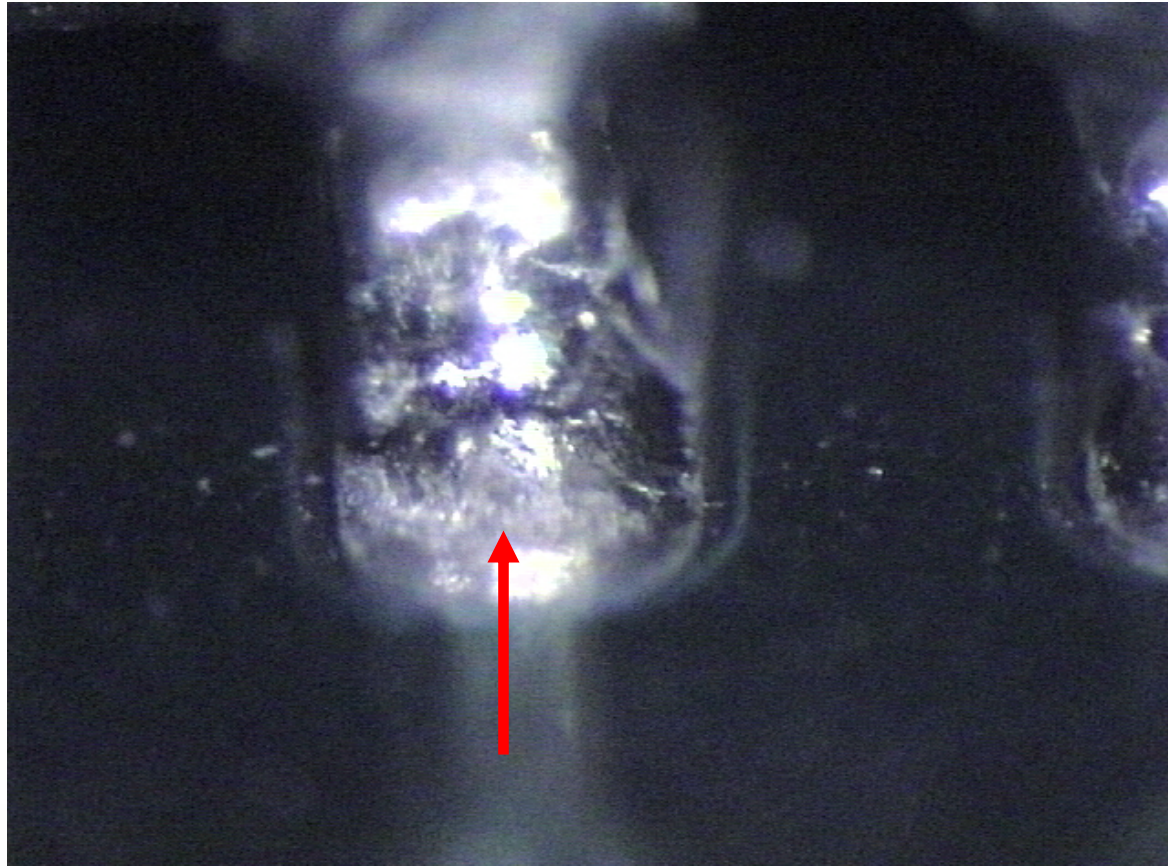
**Cracked solder joint on PLCC solder joint
after 1000 temp cycles**

- All part types except the DFN8 showed some cracks in the solder joints
- Small qty of cracked solder joints appeared severe enough to impact CCA reliability. No parts showed cracks on 100% of the leads.
- No cracks or other anomalies were observed on the component bodies.
- Damage was more widespread on larger components than smaller ones.
- Solder joints on PLCCs installed on epoxy PWBs with silver finish reflowed in air showed more cracks than on the other types of boards.
- Among all part types, there were no consistent trends between solder joint quality and PWB material, PWB pad finish or reflow condition.
- No anomalies were noted on parts with non pure tin lead-free finishes (SnBi, NiPDAu and AgPd). In very small sample sizes, parts with these finishes showed similar solder joint quality as tin mitigated components.
