Bare Board Material Performance after Pb-free Reflow

IPC/APEX March 31-Apr 2, 2009

Overview of Project

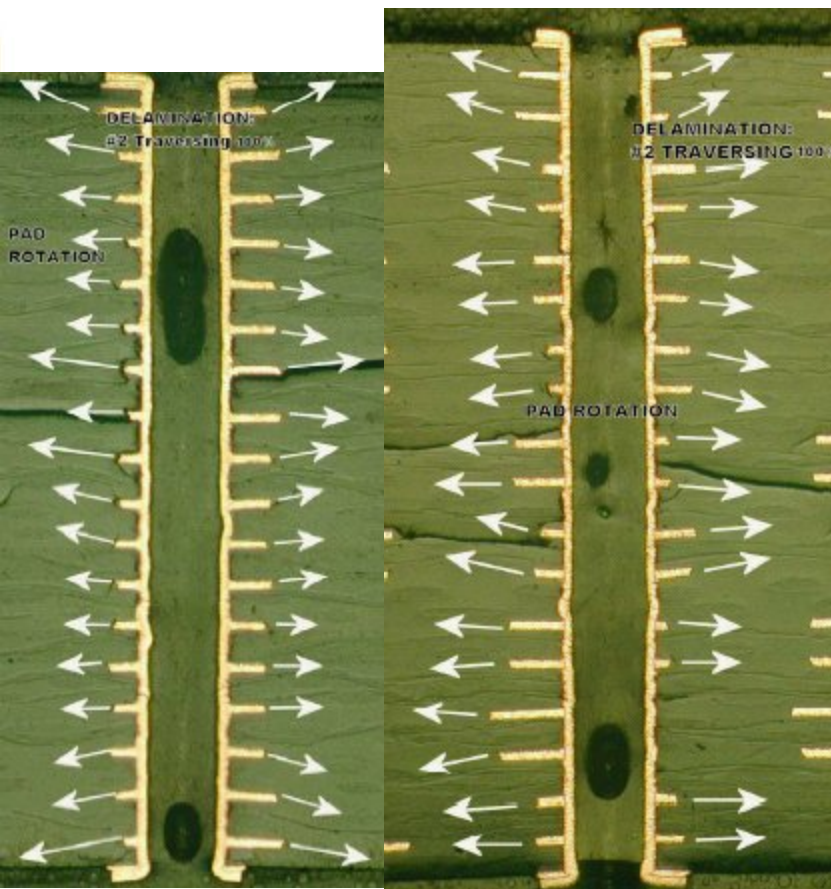
Laminate Integrity Summary

- Performance and Reliability Risks of Internal Delamination/Material Degradation
 - Possible Pathways for CAF
 - Possible Loss of Dielectric Strength
 - Possible Changes in Localized Electrical Properties
 - Reduced Via Integrity
 - False Positive Via Reliability
 - False Positive CAF test performance

- Reduction of entrapped moisture within the laminate
- Use of materials with stronger interfaces
- Use of resins with higher fracture toughness
- Also – Use of materials with lower Z-Axis CTE – reduces stresses from expansion

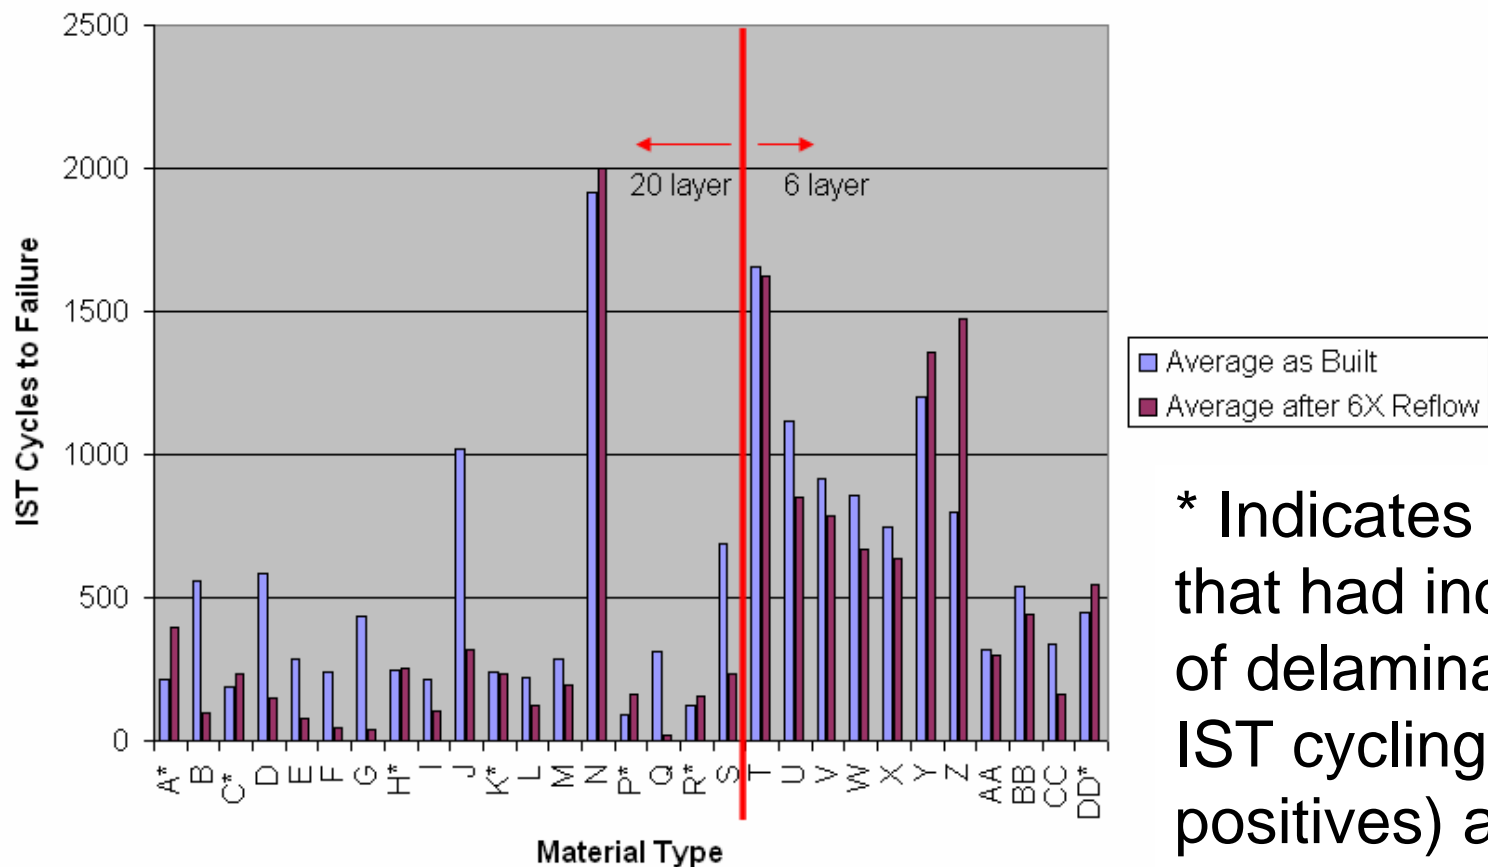
Mean IST Cycles to Failure, Before/After 6X reflow

* Indicates materials that had indication of delamination in IST cycling (false positives) after reflow

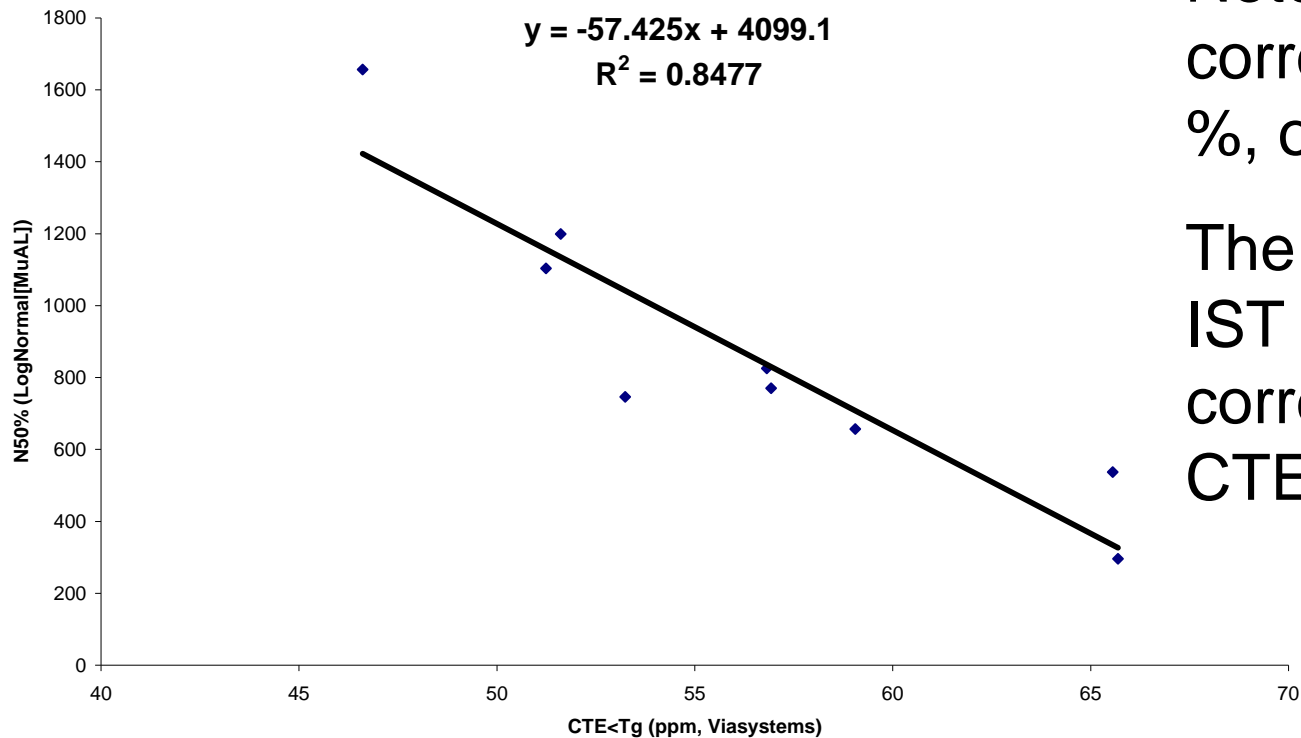
Scatter Chart (CTE<Tg (ppm, Viasystems) vs IST N50% As Built (LogNormal[MuAL]))

IST Results compared to CTE-Z (alpha 1), as Measured on the boards, 6 layer, .062 constructions only

Note – these do NOT correlate with CTE-Z %, or CTE-Z (alpha 2)

The thicker boards IST results don't correlate well with the CTE measurements

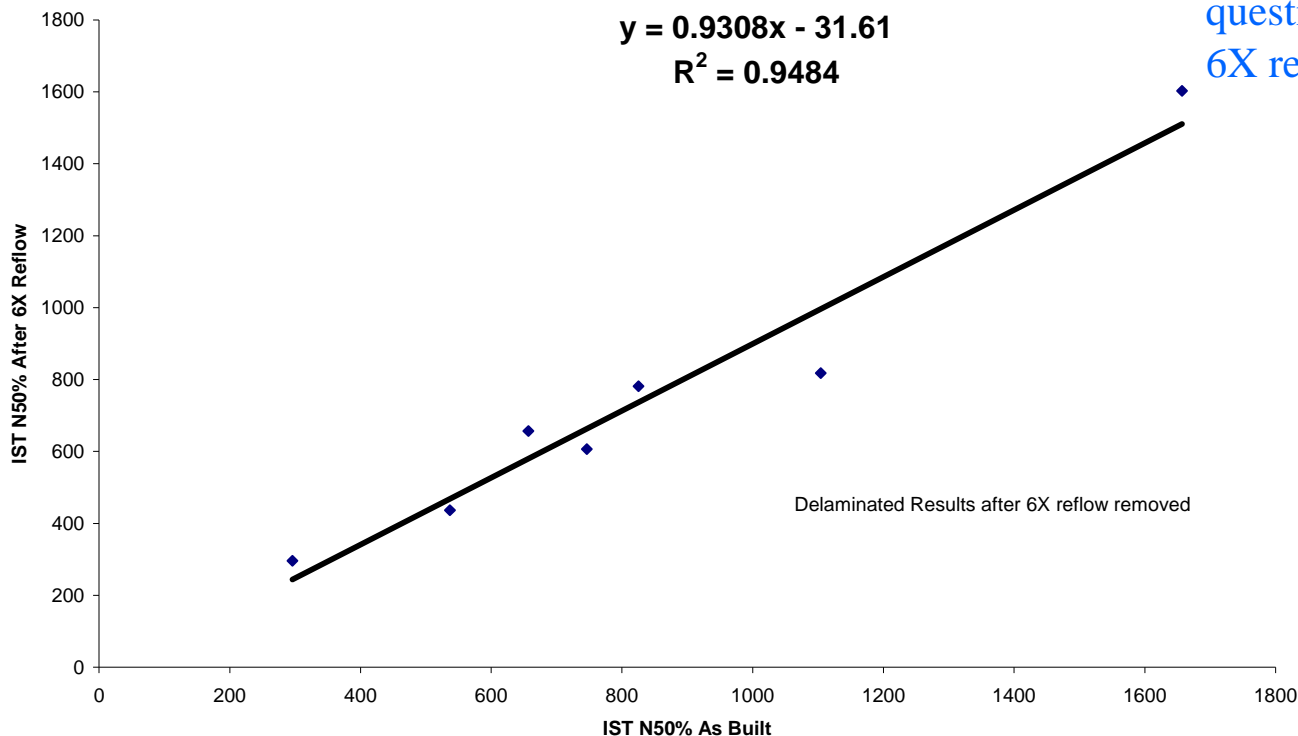
Scatter Chart. .062" Thick 6 layer coupons only (IST N50% As Built vs
IST N50% After 6X Reflow)

IST Before and After 6X Reflow: before reflow and after reflow correlate very well

7 materials: 2 materials
removed due to
question on results after
6X reflow

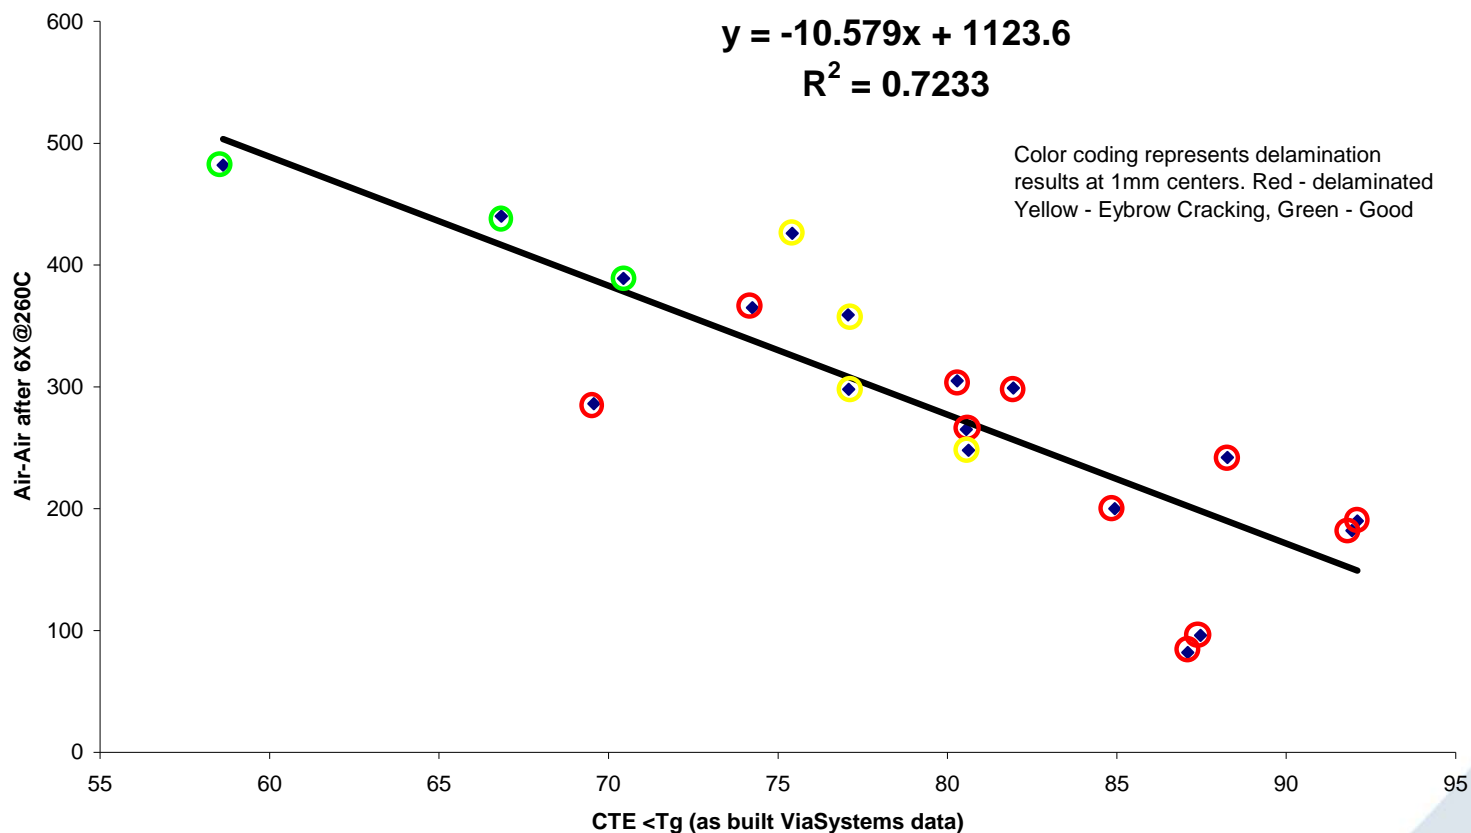
Scatter Chart (CTE <Tg (as built ViaSystems data) vs Air-Air after 6X@260C)

ATC results correlated to Actual CTE

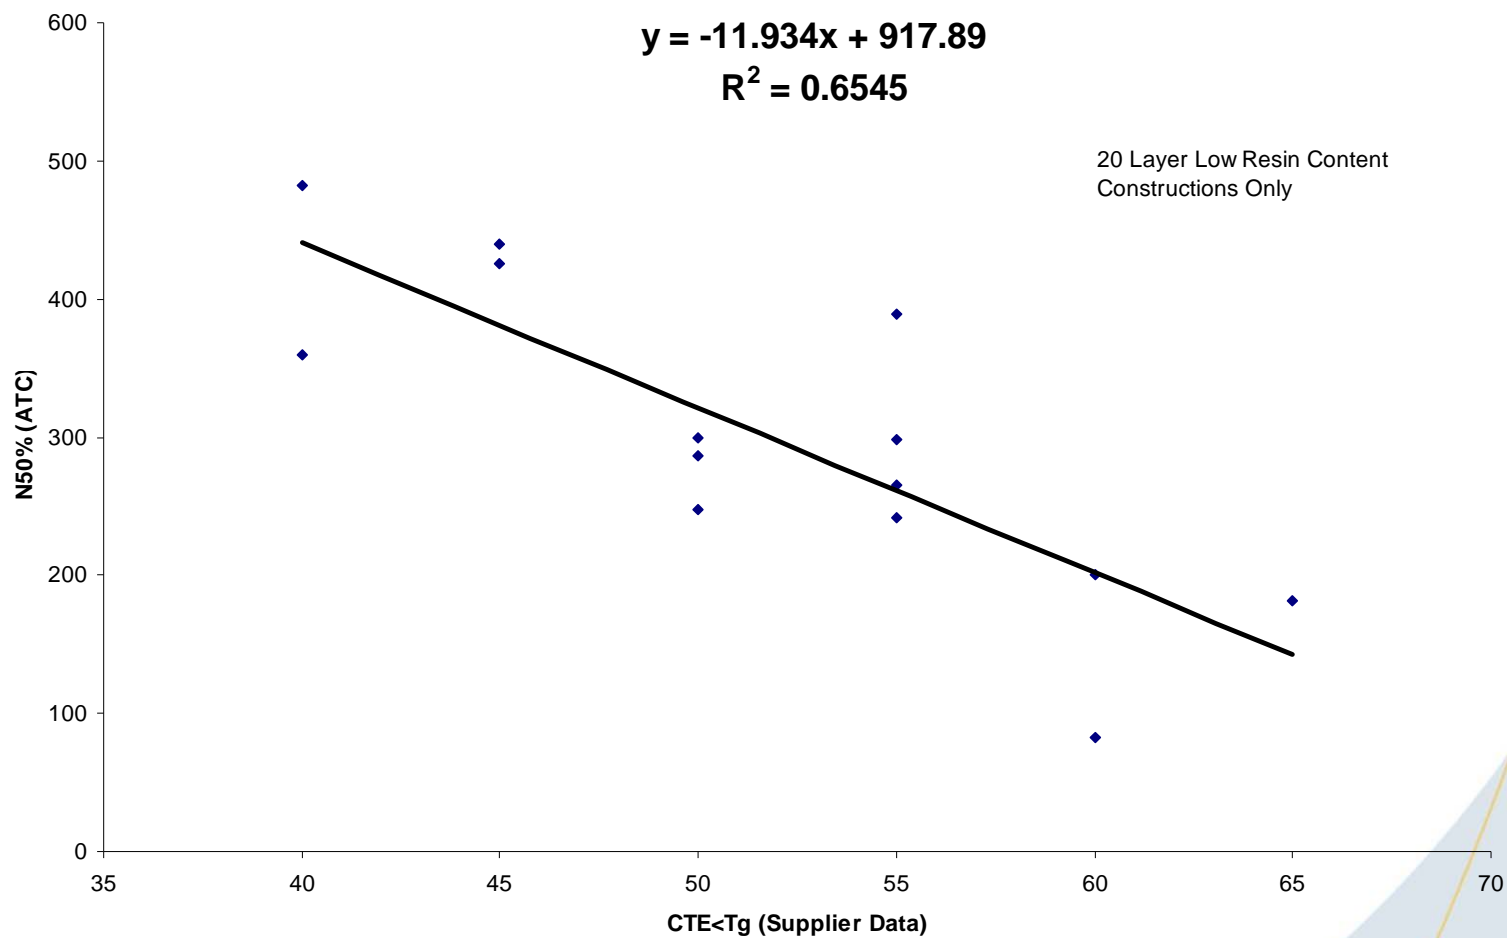
Scatter Chart (CTE<Tg[Supplier Data] vs. N50% ATC)

Supplier Data Sheet CTE's don't track so well

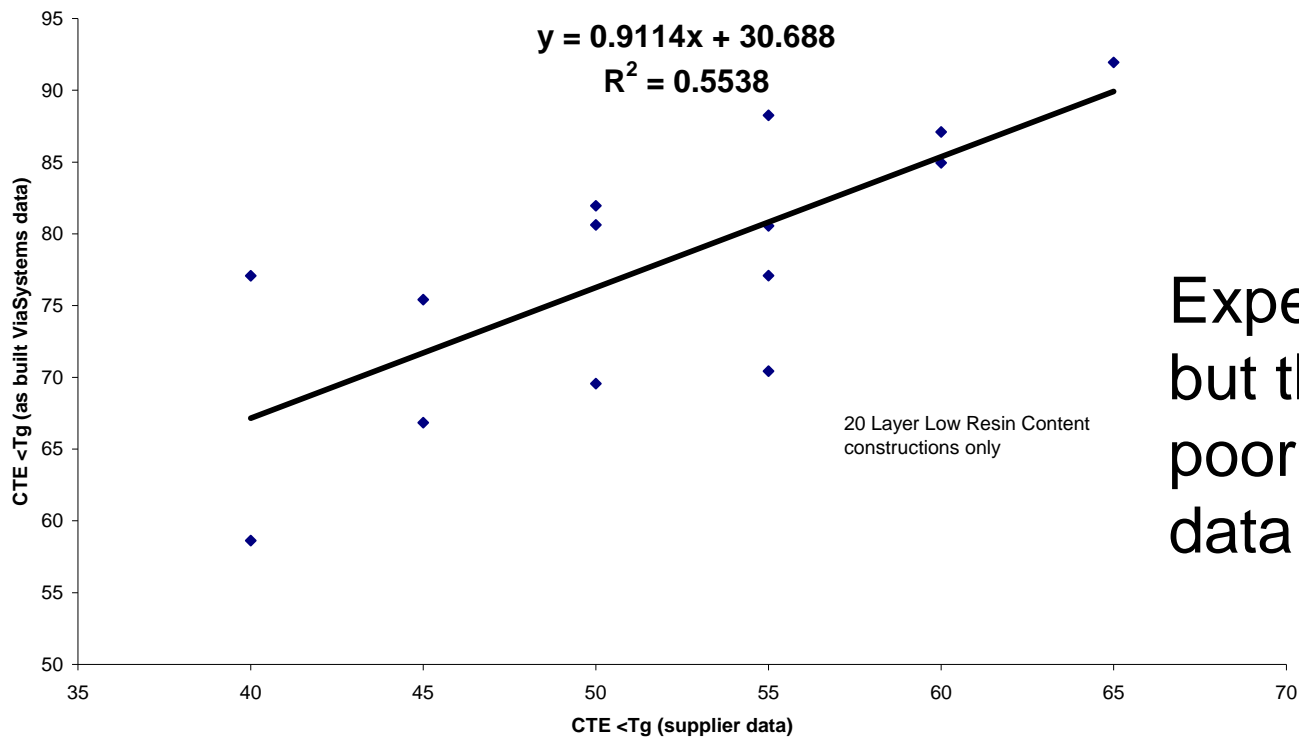
Scatter Chart (CTE <Tg (supplier data) vs CTE <Tg (as built ViaSystems data))

Measured CTE-Z vs. Supplier Data Sheet CTE-Z

Expect a difference — but the correlation is poor and the fit of the data is terrible

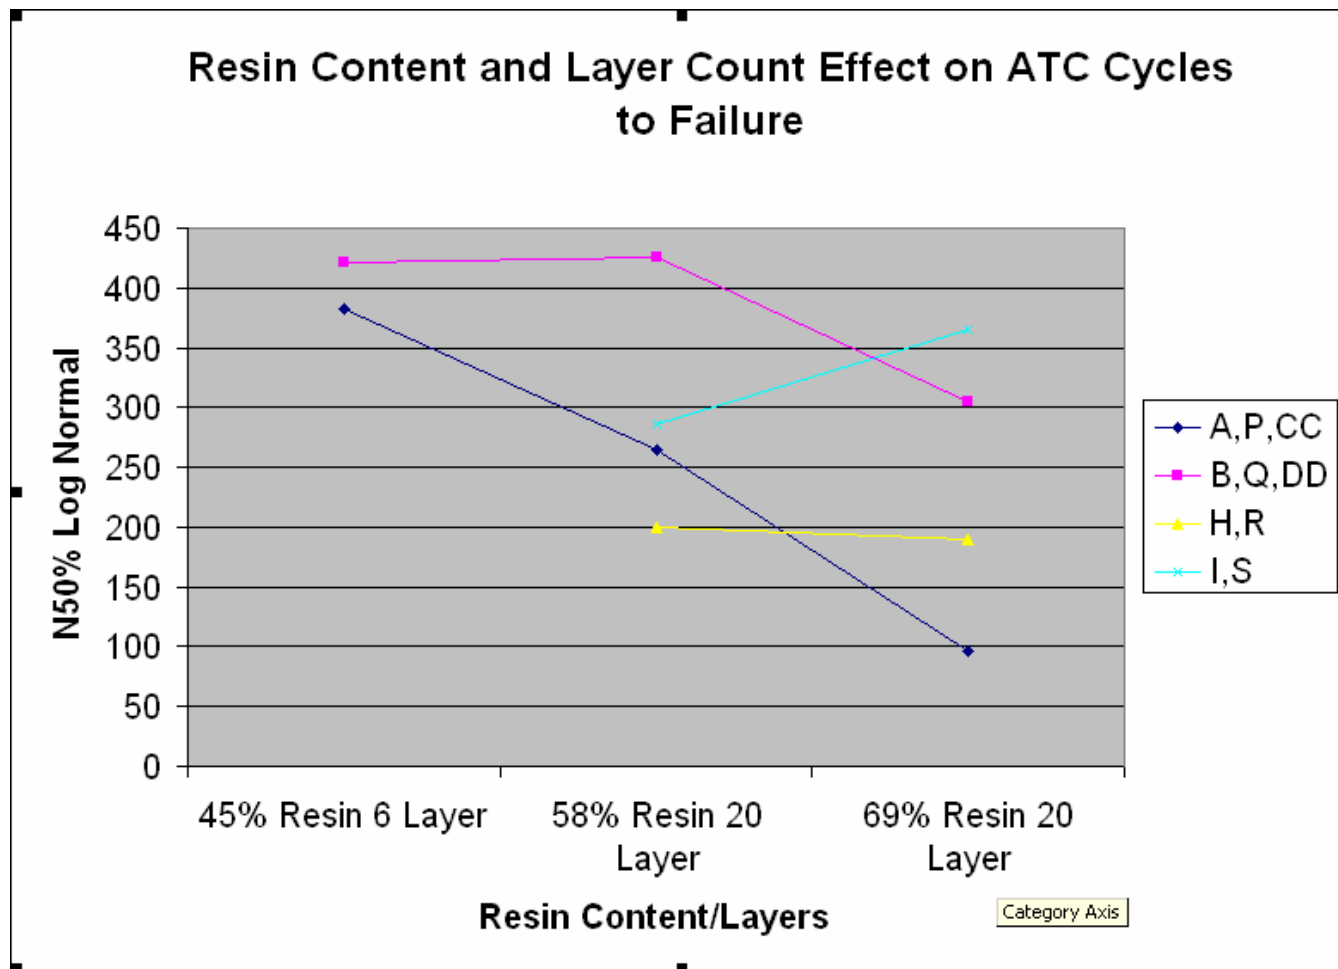
Resin Content and Layer Count Effect on ATC

Primary effect is Resin Content – directly linked to Z-CTE
Layer count is a secondary affect

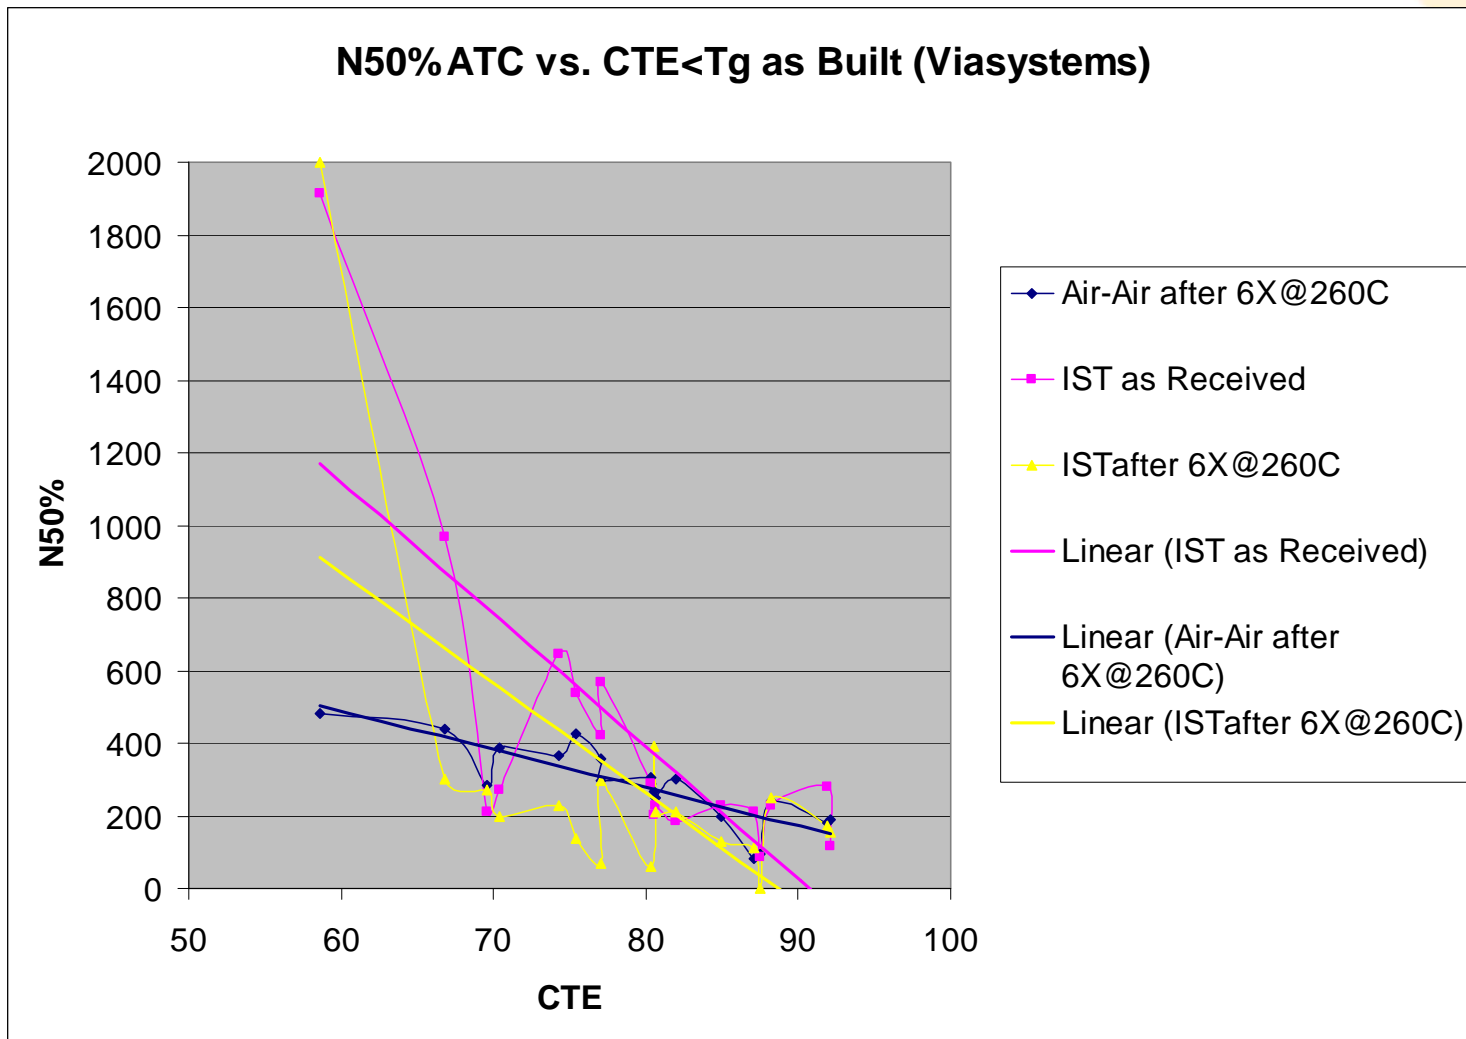
IST and ATC vs. CTE (20L)

- First – comparison must be same constructions (graph on previous page is) – these are all 20 layer, 58% RC – but correlation is poor
 - R^2 between the ATC and IST results is only .43 and .47 for as built and after 6X IST respectively (plots not shown), and the fit of the data is poor.
