Whisker Growth on SAC Solder Joints: Microstructure Analysis

Polina Snugovsky, Zohreh Bagheri, Marianne Romansky
SMTA Toronto, May 15th, 2008

History of the Examined Samples

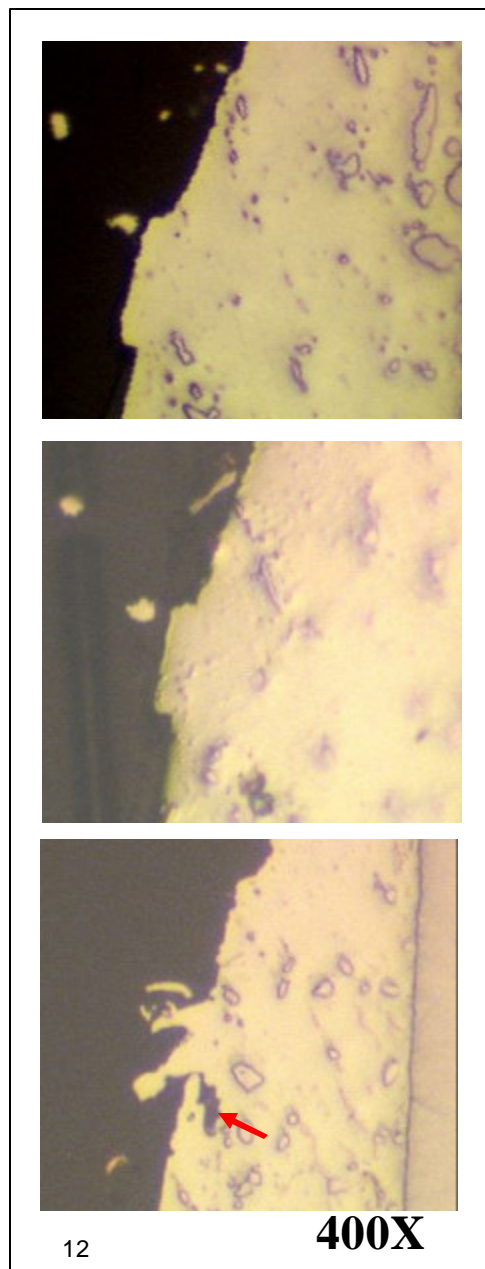
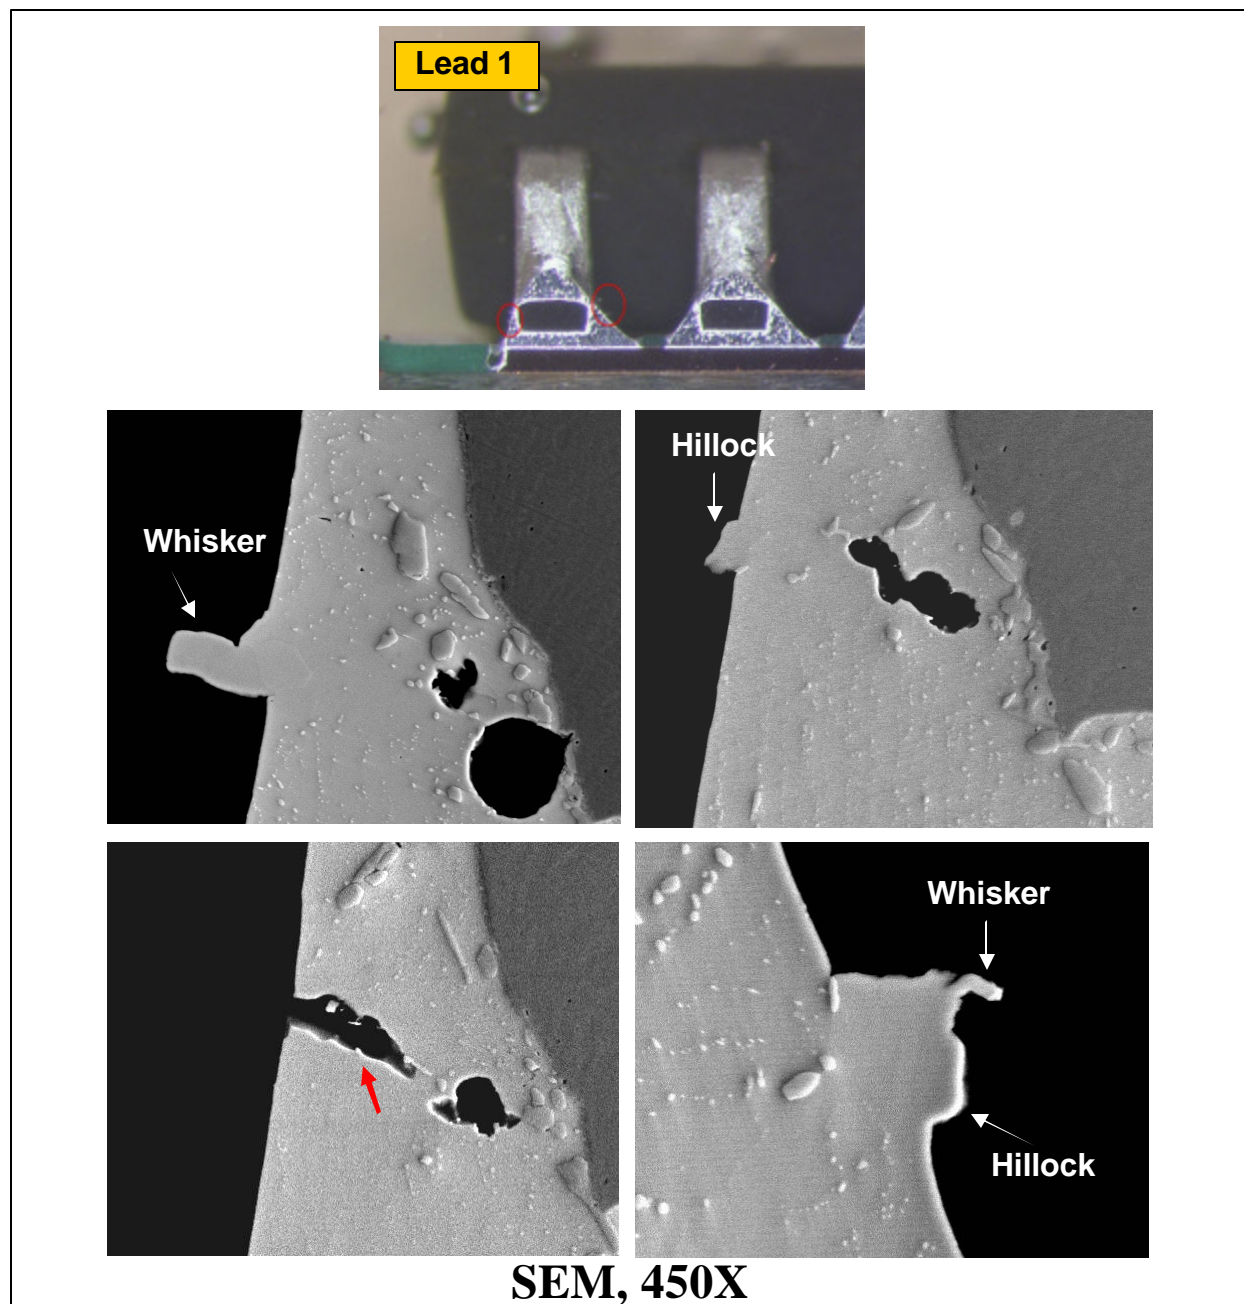
Hillock Shape Evaluation and Connection with Whiskers

- Different from the bulk solder microstructure
- Contains the recrystallized Sn grains and
- Very few intermetallic particles
- It seems that the hillock emerged through the hole in a surface Sn oxide film
- The intermetallic particles are distributed non-uniformly and located only in the centre of the hillock
- The intermetallic particles contain either Ag or Cu in addition to Sn
- The rest of the protrusion is pure Sn
- It is possible that the solder was depleted of Ag and Cu by extensive diffusion caused by oxidation or corrosion
- The recrystallized grain size is smaller at the base of the hillock than in the hillock itself

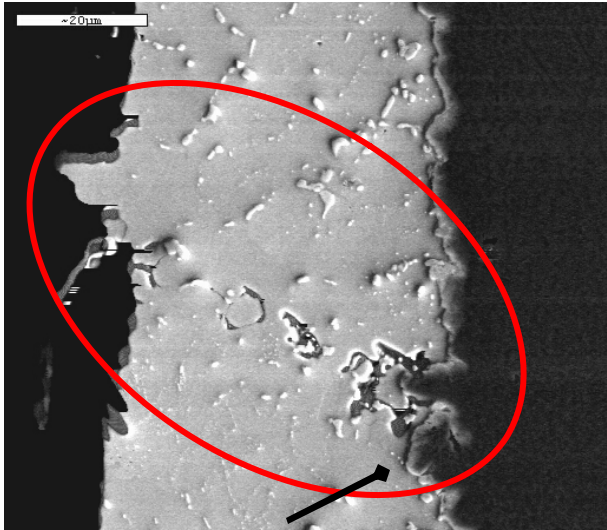
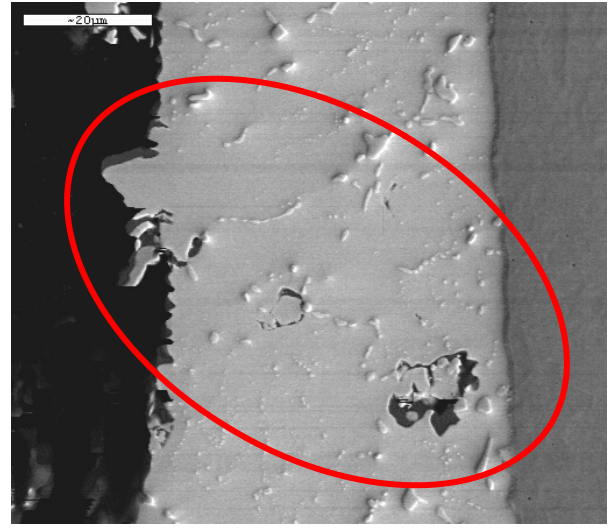
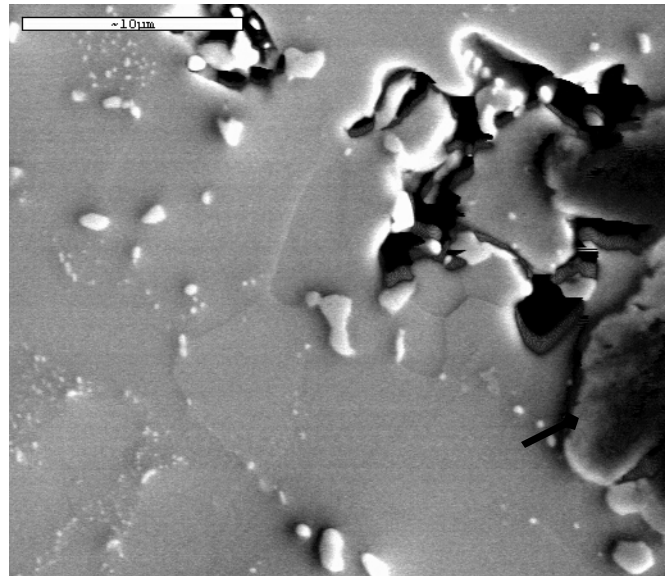
Area 1

- Co-existence of voids with hillocks and whiskers
 - The corrosion channels are traceable to large outgassing voids
 - The voids are often related to the rough interface
- Corrosion channels near the rod whiskers or hillocks
 - Propagate through the eutectic structure in spaces between the dendrites' arms and have a dendritic shape
 - In some cross-section planes, they look like separate voids, but sequential polishing shows that they are always connected

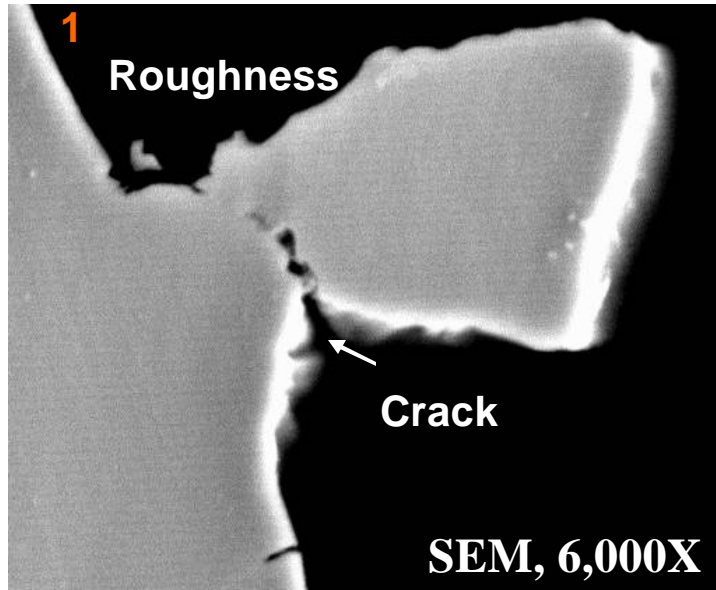
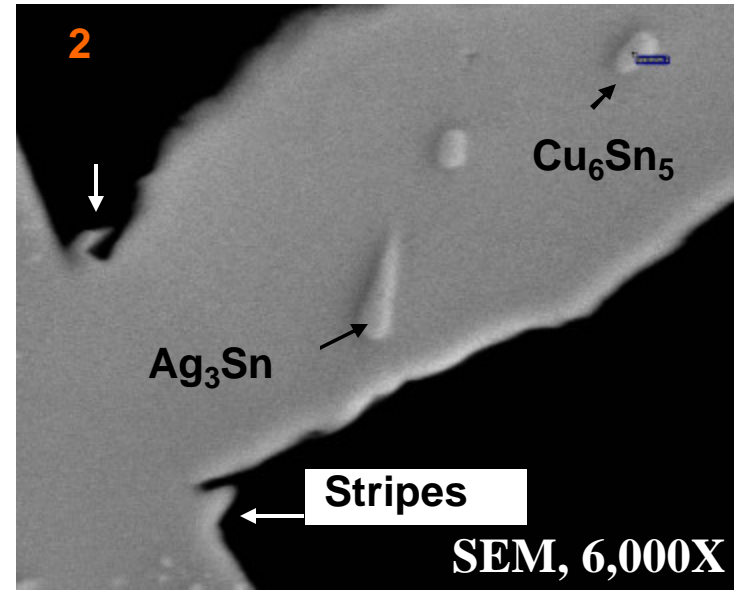
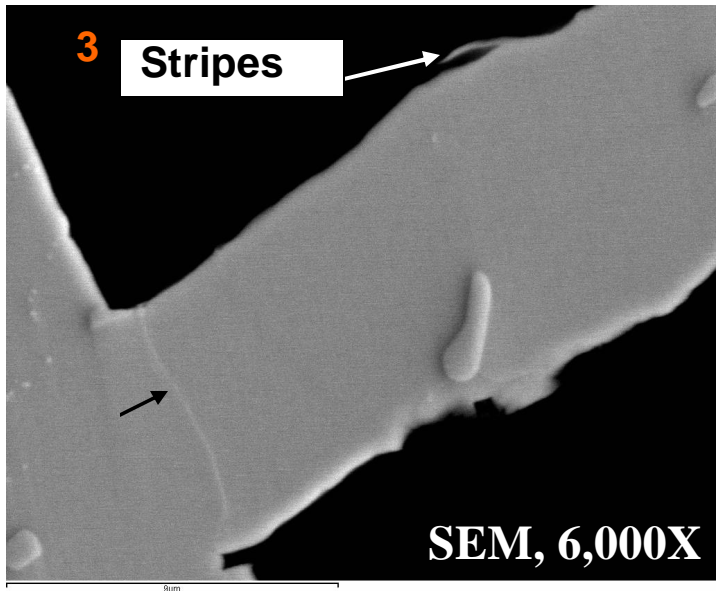
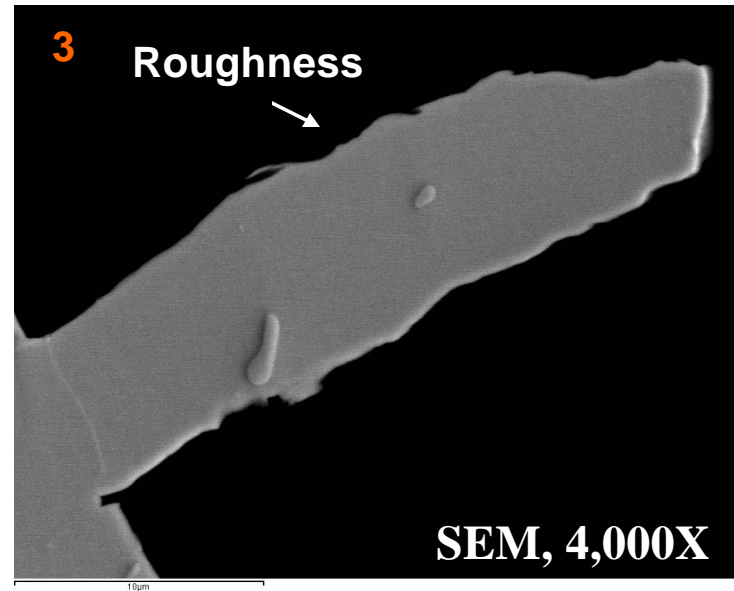
- The shell-like protrusions have a similar microstructure to the hillocks
 - Sn matrix with very few Cu_6Sn_5 and/or Ag_3Sn particles
- The two-dimensional striations are evident as
 - A surface roughness at the edges of the protrusion and
 - Stripes in the parallel direction
 - Black lines or wrinkles
- The cracks look like a separation between the grains
