Electrical Failure of an Accelerator Pedal Position Sensor Caused by a Tin Whisker and Discussion of Investigative Techniques Used for Whisker Detection

5th International Tin Whisker Symposium

Failure Analysis of 2003 Camry APP Sensor

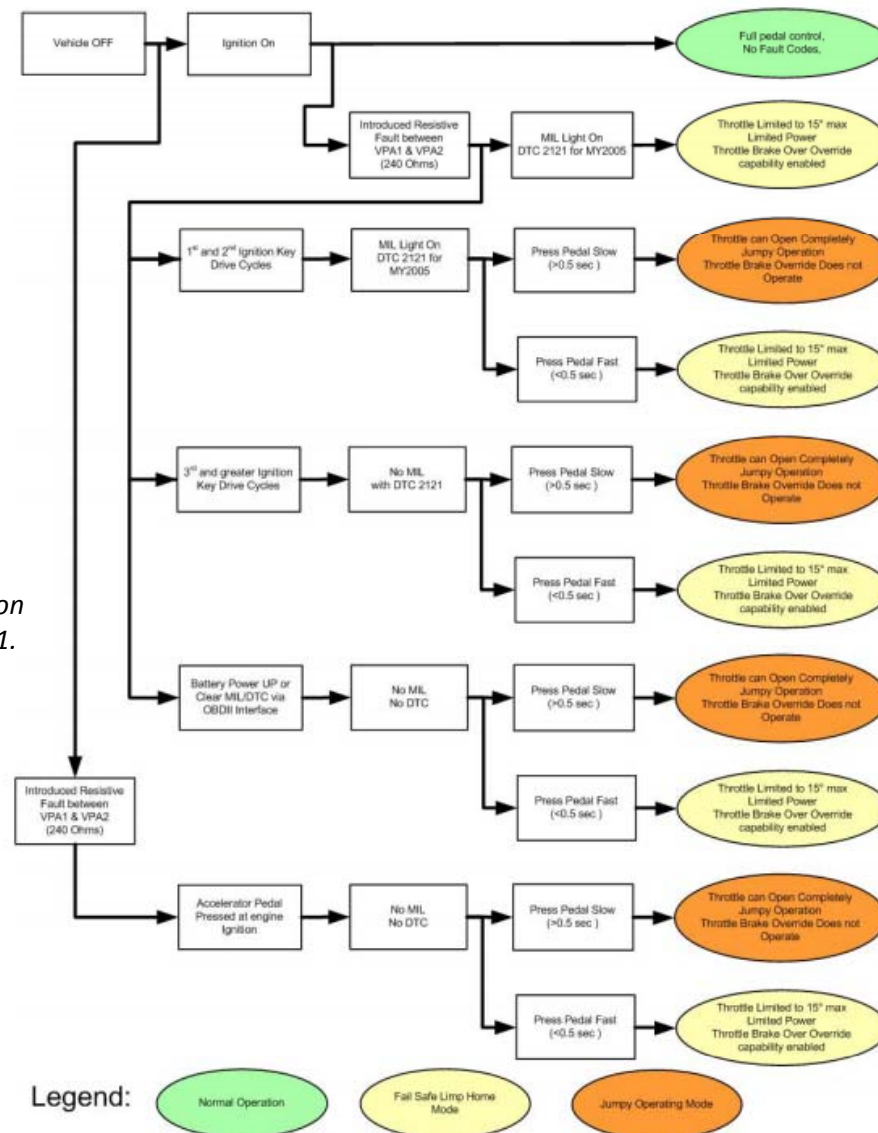
Figure 6.6.2.3-2. Pedal Resistive Fault Event Sequence Diagram

- Vehicle testing of a MY 2005 Toyota Camry demonstrated that a 248 ohm short between VPA1 and VPA2 results in different vehicle responses depending on the sequence of operations following the fault
 - *If the pedal is depressed quickly, then throttle is limited to 15 degrees*
 - *If the pedal is depressed slowly, then throttle can jump to 15 degrees, and further pedal application can achieve wide open throttle*
- In all cases, releasing the accelerator pedal closes the throttle, and brakes are fully operational
 - *Although the vehicle would operate, we did not consider it to be driveable*

This chart is not self-contained, but requires the materials in the section 6.6.2.3.1 of the NESC Technical Assessment Report

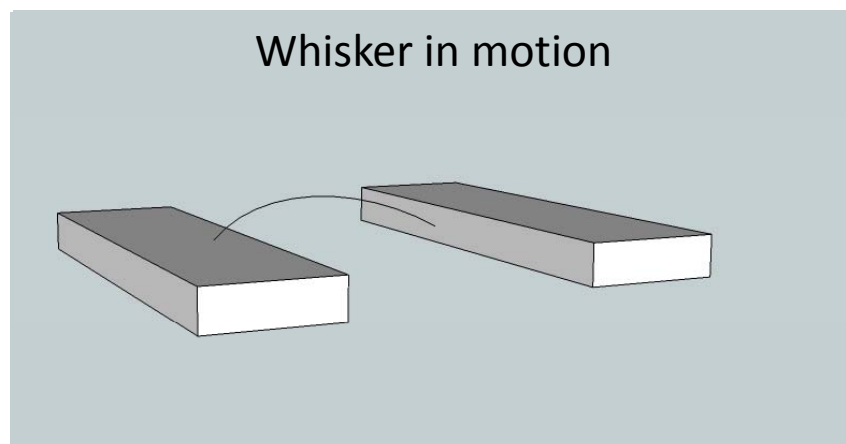
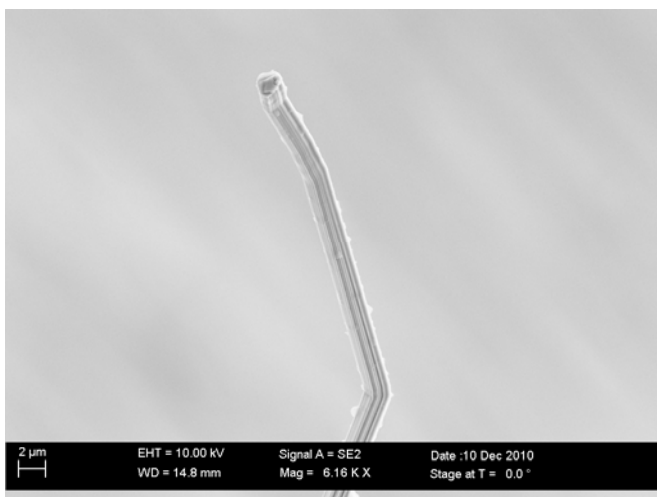
Illustration of How a Whisker may Snag

- Long, thin whiskers are ductile. Without breaking they can bend, flex through very large angles under the influence of air, vibration, shock, electrostatic forces
- After significant movement, whisker tip may be caught by the irregular surface of the tin plating on an adjacent conductor
 - Mechanical shock or air movement may dislodge the whisker tip
- **Insulating films may prevent immediate electrical continuity**
 - See next slide for more detail

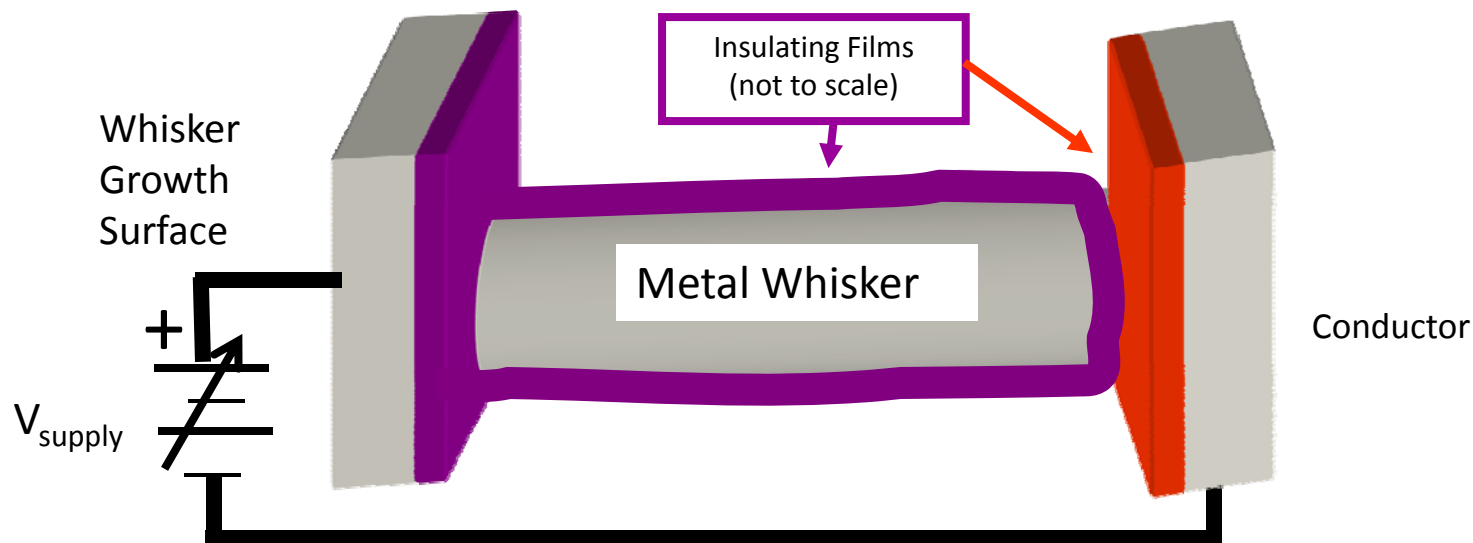
Metal Whiskers and Adjacent Conductors Grow Insulating Films

- Electrically insulating films form within hours on metal whiskers and adjacent conductors
 - Oxides, sulphides, sulphates, chlorides, hydrides, etc.
- These films act as barriers to electrical current flow UNLESS applied voltage exceeds “dielectric breakdown” strength of the combined films
 - Direct **MECHANICAL** contact does **NOT** guarantee **ELECTRICAL** contact
 - Courey (NASA), among others, have measured the breakdown voltage of films on tin whiskers
 - V_{BD} fit a probability distribution with a wide range (~60mV to >45Volts)
 - Insulating effects of these films are important to recognize
 - Has fooled failure analysts when bench testing (e.g., Ohm-meter) to detect shorts
 - **Can explain survival of some electronics in the field despite whisker infestation**

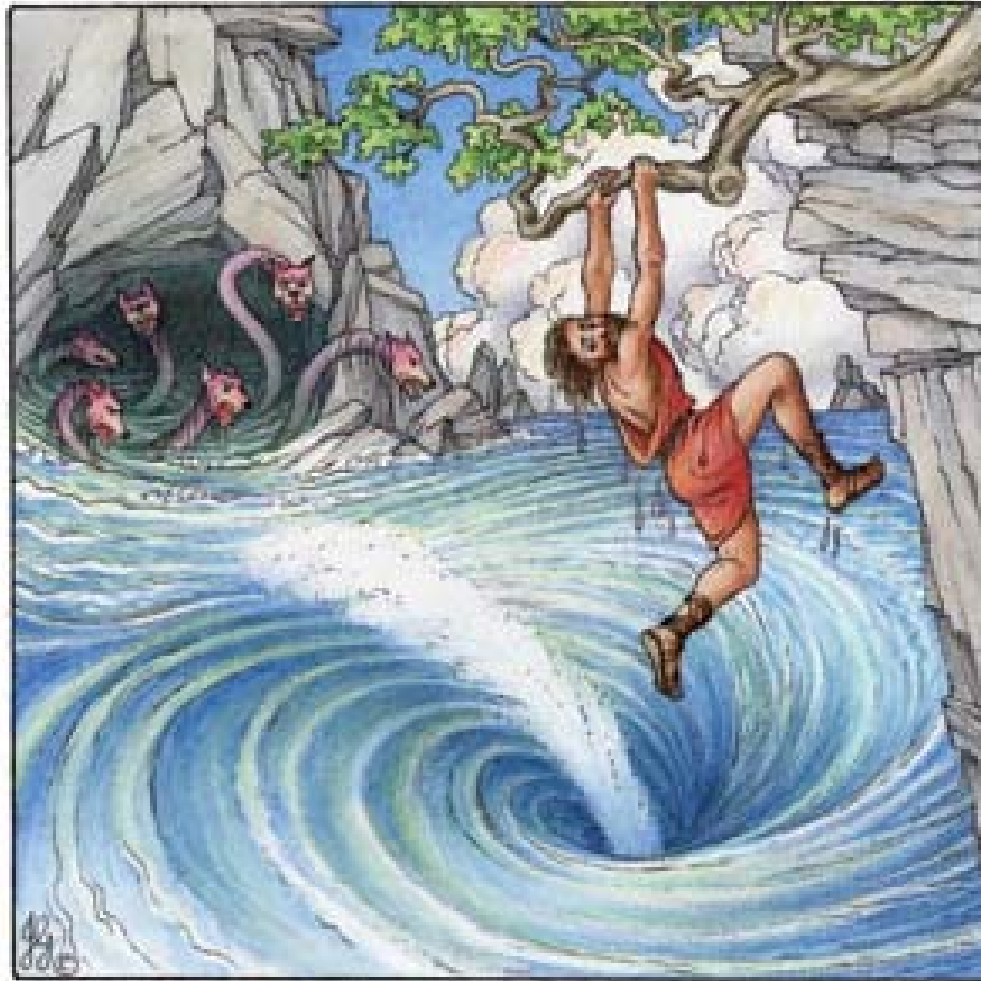
Electrical Detection of Whisker Short Melting Whisker vs. Insulating Film Interference

- Published research shows that ohm-meters detect less than 10% of the bridging whiskers, and sometimes less than 1%
- The investigator may conclude **“No Fault Found”**
 - Ohm-meter may supply $V_{out} < V_{breakdown}$ for the insulating films (oxides, moisture) that form on a metal whisker. No Current will flow – the whisker remains undetected during the few seconds of examination.
“No Fault Found”
 - Ohm-meter may supply $V_{out} > V_{melt}$. Current Will Flow, the whisker melts in less than 1 ms -- no detection happens. There is no longer a bridging whisker to detect.
“No Fault Found”
- Range switching can have the ability to deliver whisker-killing impulses
