No-fault-found and intermittent failures in electronic products

Haiyu Qi*, Sanka Ganesan¹, Michael Pecht

CALCE Electronic Products and Systems, University of Maryland, College Park, MD 20742, United States

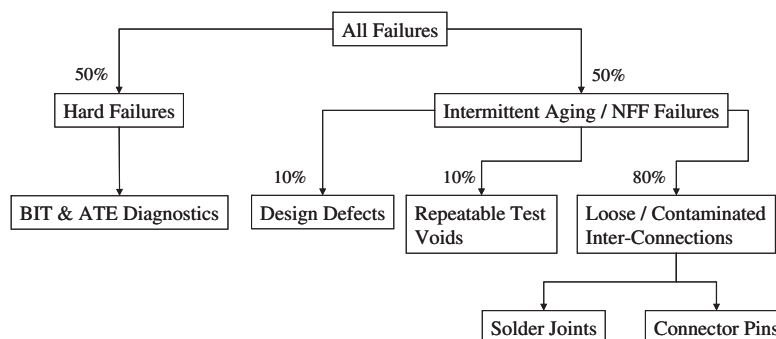
Fig. 1. Hard failures and NFF failures on military aircraft [9].

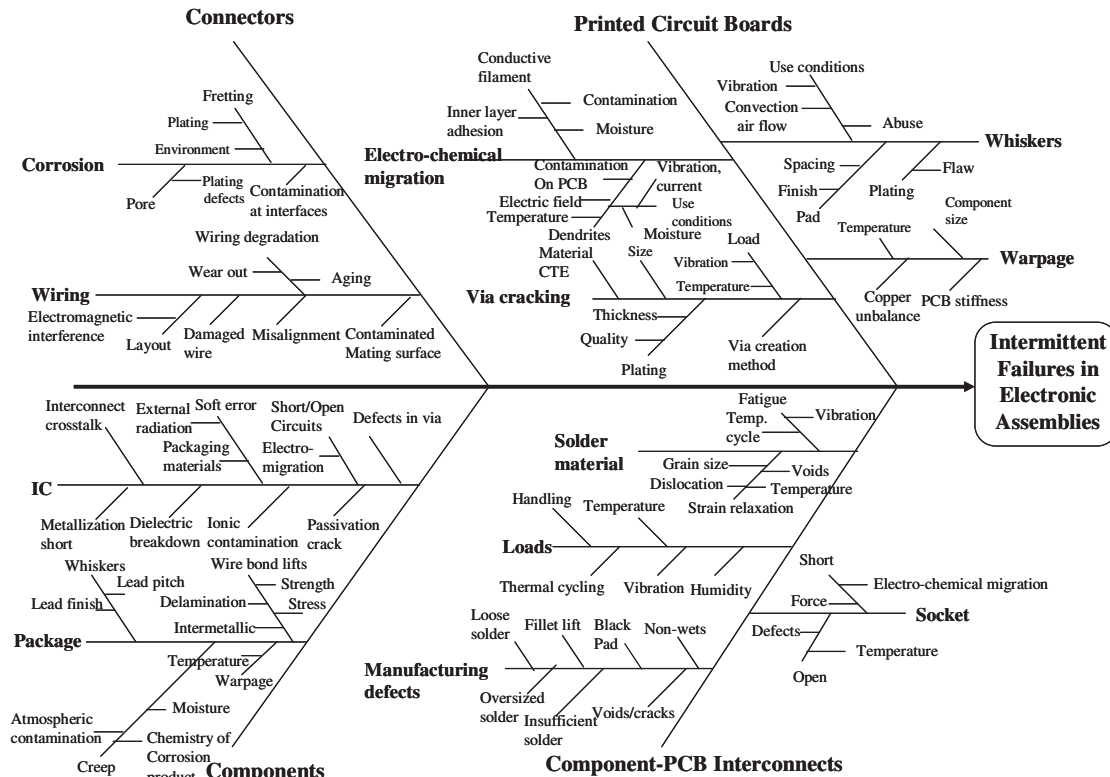
Fig. 3. An example cause-and-effect diagram of intermittent failures in electronic assemblies.

To evaluate the possible causes of intermittent failures in an electronic assembly, a cause and effect diagram was developed in this study (see Fig. 3). The major causes are categorized into printed circuit board (PCB), components, connectors and component-PCB interconnects. Some examples of failure mechanisms observed in the field and laboratory tests for each category of intermittent failures are presented.

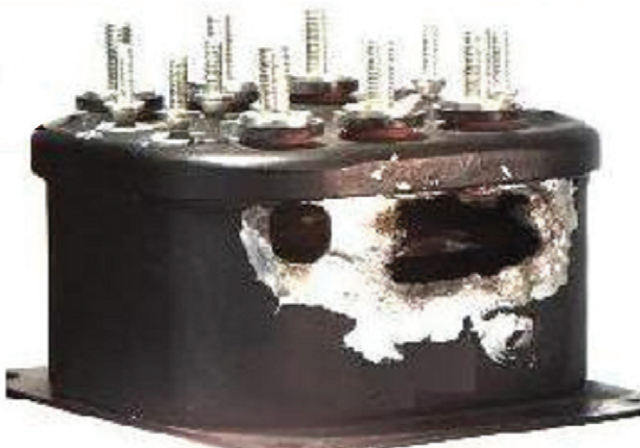
Fig. 12. Failed relay due to tin vapor arcing.

Fig. 12 shows a relay which failed due to tin vapor arcing. Failure analysis concluded that tin whiskers initiated the current surge to the ground. Once a whisker bridged a terminal stud to the armature, plasma arcing could occur with enough voltage and current to damage the relay or just cause an intermittent short [40]. Fig. 13 shows whiskers on the armature of a relay.

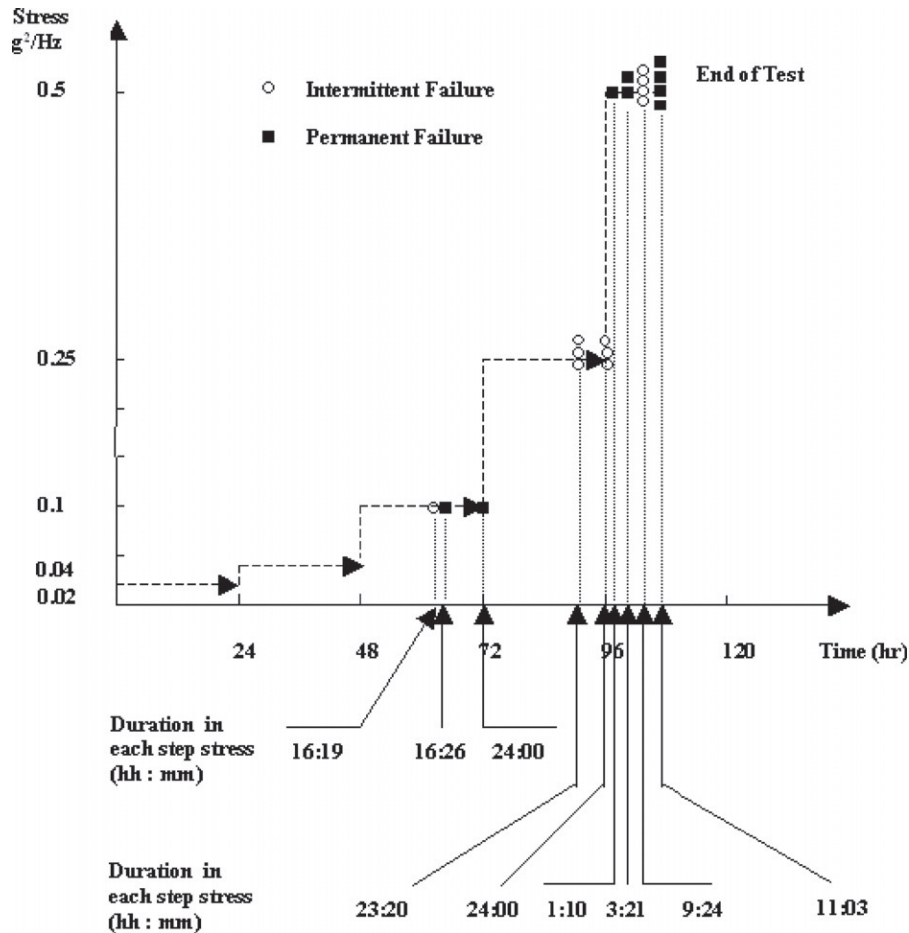
Fig. 16. Failures in vibration stress test.

Table 2 summarizes the occurrence of intermittent and permanent failures at each stress level. Fig. 16 illustrates the vibration step stress process and the occurrence of failures during each stress level. There were no failures at vibration level 0.02 and $0.04 \text{ g}^2/\text{Hz}$ at the end of the 24-h duration. At the vibration level $0.1 \text{ g}^2/\text{Hz}$, one intermittent failure occurred after 16 h and 19 min on the non-underfill assembly. Seven minutes later, this intermittent failure became a permanent failure. When the vibration stress level was increased to $0.25 \text{ g}^2/\text{Hz}$, two intermittent failures occurred on the non-underfill assembly and one on the underfill assembly at 23 h and 20 min. With the vibration stress level of $0.5 \text{ g}^2/\text{Hz}$, two previous intermittent failures on the non-underfilled assembly became permanent failures at 1 h and 10 min and 3 h and 21 min, respectively. At 9 h and 24 min, three more intermittent failures occurred on non-underfilled assembly. The experiments were stopped after 11 h and 3 min at $0.5 \text{ g}^2/\text{Hz}$ vibration level with 4 intermittent failures and 4 permanent failures.
