Tin Whiskers – A Long Term RoHS Reliability Problem

Robert J. Landman, President, SM IEEE
H&L Instruments, North Hampton, NH

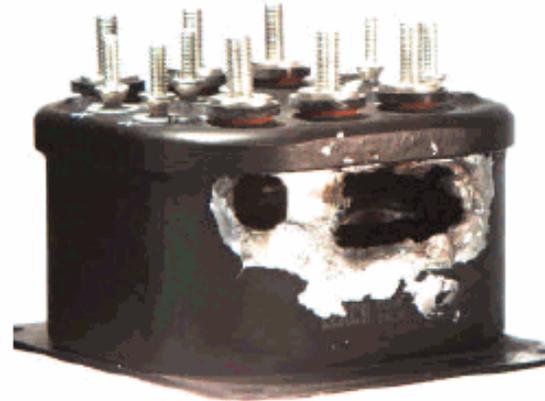
3 Relay failures from a Military Aircraft -- approximately 10 years old. Failed in 1998. Rated at 25 amps/115 Vac/3 phase

Figure 1 - Failed relay

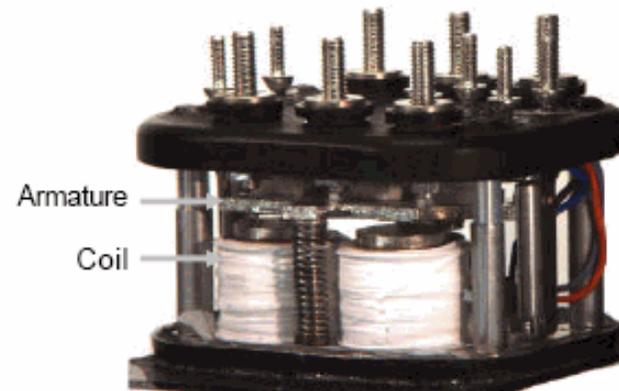
Figure 2 - Opened un-failed relay
